Appendix D: Extract from Druskovich (2009) – Section 4**4. ARCHAEOLOGICAL SITE AND MANAGEMENT UNIT RECOMMENDATIONS**

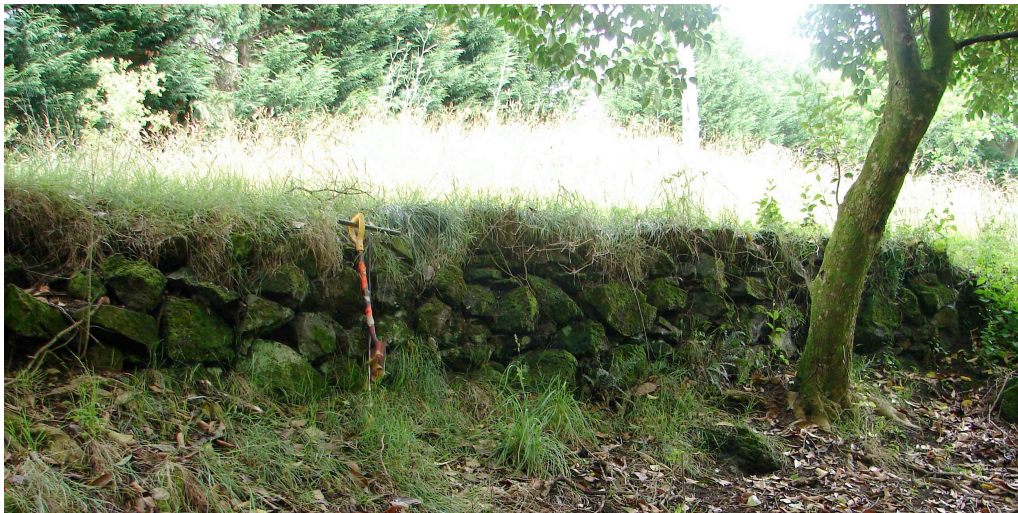
Currently this retaining wall is in good shape, however some trees are growing close to it. The area above it appears to still be used as an occasional vehicle track and is grassed.

Plate 9. R11/2473 illustrating close proximity of a tree.

- i) Trees close to this wall should be assessed as to whether their roots are likely to compromise the site, and removed if necessary.
- j) That the track above the wall is maintained as an occasional access route so that the wall is kept in its historical context.
- k) That the area above the wall is kept in grass, and should any items be planted below the wall they are planted so as not to obscure the wall from the path and R11/2373. Any trees planted in this vicinity should be done so at sufficient distance so their root systems do not interfere with the wall stability.

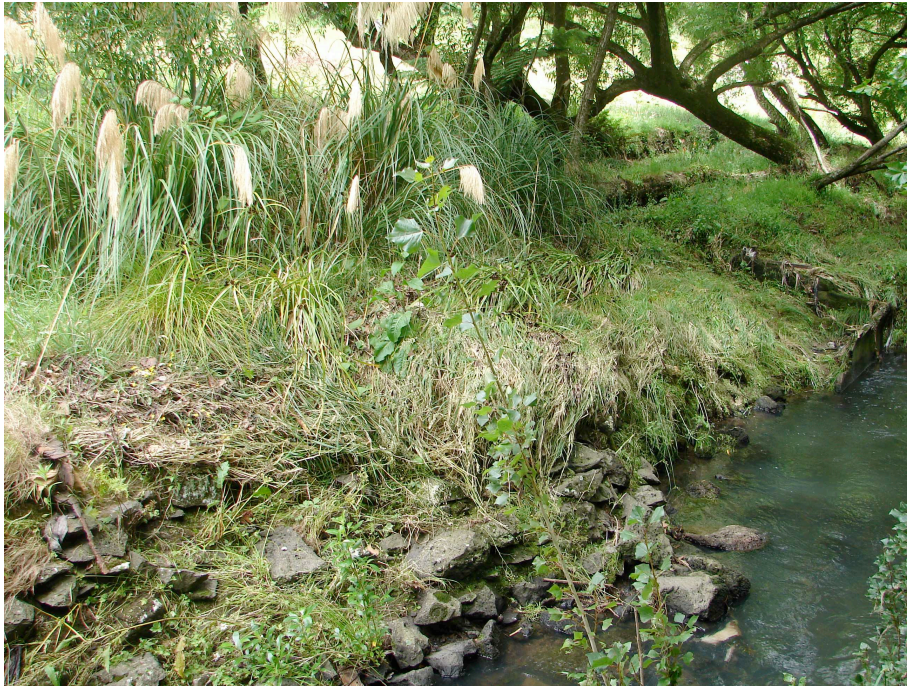
This site is compromised by both recent and historic plantings, and/or self sown plants. Some of these plants should be removed to ensure that they don't further compromise structure stability.

Plate 10. Toetoe above the stone bridge foundations, willows (background) over approach track to bridge, eastern side, these should be removed.

- l) That vegetation (other than grass) is removed from above or adjacent to the stone structures. This includes the toetoe on the western bank. Their removal could be mitigated by planting the creek bank (within 500mm where adjacent to the site) where stone and other works aren't present in the immediate vicinity.
- m) That the willows and recently planted seedlings are removed from the track below the retaining wall so that the site historical context is retained. The area surrounding the site (on the eastern side of Oakley Creek) should be maintained as open space and in mown grass to assist in illustrating its past farming context. No more plantings should occur in this vicinity (creek banks excepted).

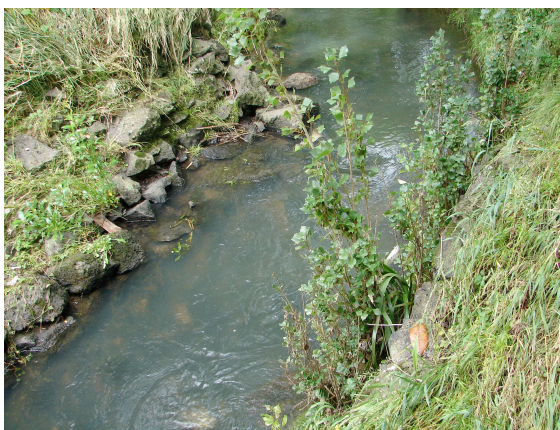
Plate 11. New growth from the poplar amongst stone bridge foundations, R11/2373.

- n) That the poplar on the western side of the creek is retained, it is of some age and is clearly part of the historical plantings related to the site, however new growth should be routinely trimmed so that it does not further damage the bridge foundations that it is already partially growing over.

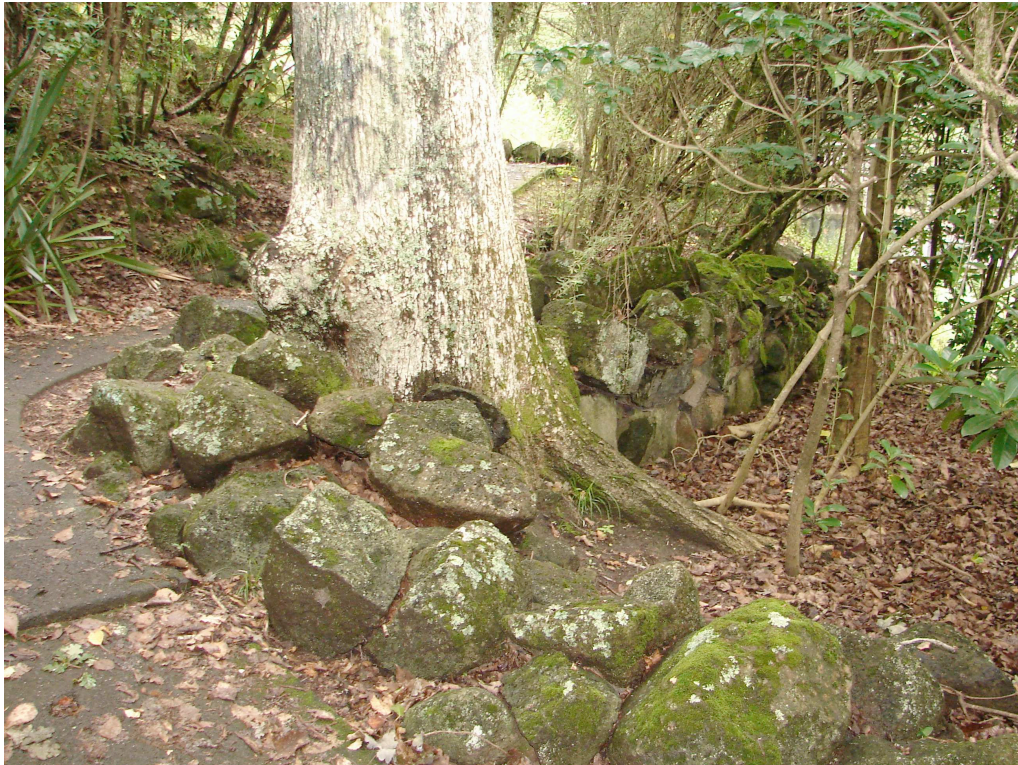
This drystone wall is adjacent to, and has the walkway pass through it, and is generally in good condition. There are a number of trees growing adjacent to

and on/over it, these trees are of a vast variation in age and size and likely to have varying effects upon the structural integrity of the wall.

Plate 12. Large historic planting amongst the stones of R11/2108 near the southern end. This tree should not be removed as it is part of the history of the site, however other smaller trees that may also grow to such proportions should be removed if they threaten the integrity of the wall.

- bb) Unsuitable trees or plants with large root structure should be removed from the near vicinity of the wall.
- cc) Active maintenance of the site should occur, removing any self sown seedlings (unless they are of a suitable species).
- dd) As it is an area (management unit 5) where active revegetation is taking place, all community groups working in this area should be made aware of the wall's historical significance and any plantings near the wall should only be of species with small root systems.

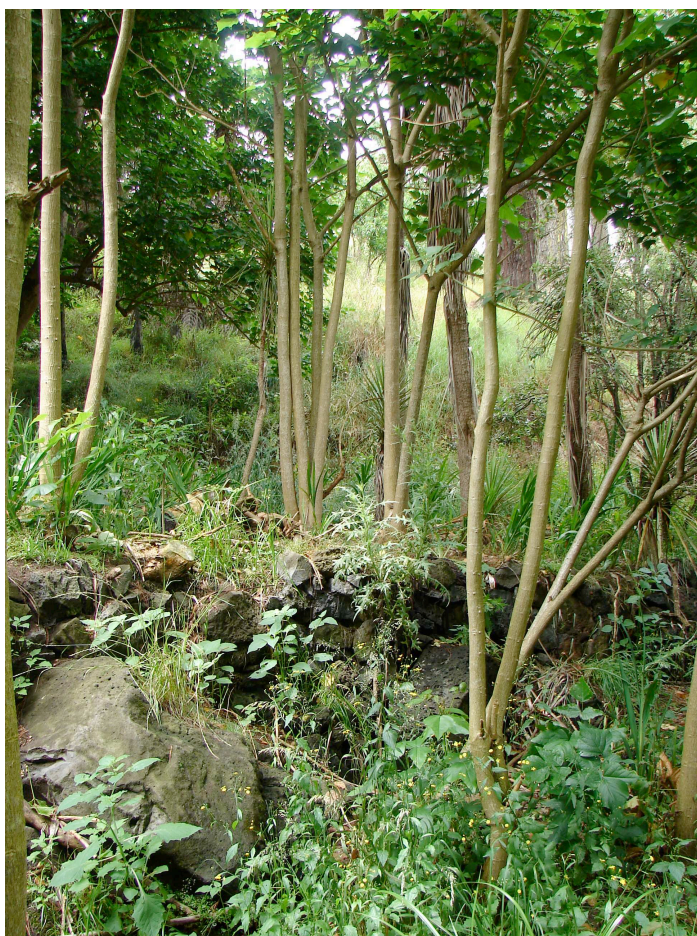
The stone wall acts as a retaining wall, back from the eastern bank of Oakley Creek, it is of drystone construction and has recent and semi-distant past plantings in its general vicinity. Many of these appear to be of large species trees, Plane and Puriri, and may not be suitable, for the continued structural integrity of the wall to be situated here.

Plate 13. Young saplings growing in close proximity to the drystone retaining wall.

- ee) Trees growing near the wall should be audited for suitability. Trees that are, or are likely to damage the structural integrity of the wall should be removed and their root systems allowed to rot in place. Species of plants that may regrow from the roots should be poisoned.
- ff) Active maintenance of the site should occur, removing any self sown seedlings (unless they are of a suitable species). Replacement trees could be planted within the vicinity as long as they are unlikely to cause future structural damage to the wall.

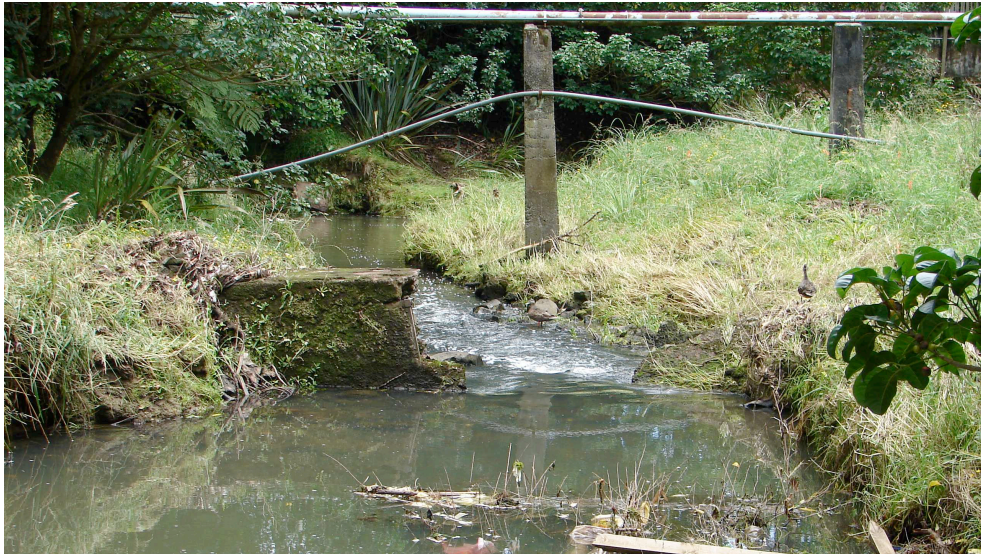
On both sides of the creek the remains of a structure, presumably a rudimentary crossing are present (another possibility is that it was a dam – refer view in Plate 14). Those remains on the western side are in a better state of preservation than those on the east. This structure is unlikely to pre-date 1900, and therefore would not qualify as an archaeological site under the Historic Places Act legislation. It is not so clear whether it could be defined as an archaeological site under the Resource Management Act, which legislates to protect archaeological sites but does not define them. Nevertheless I believe it should be retained as it is a rare historic artefact in the urban setting that illustrates the make do, no 8 wire mentality that New Zealand farmers have been credited with.

Plate 14. Remains of the crossing (dam?), showing relatively intact western side, the eastern side is discernibly collapsed on the right.

gg) Creekside plantings should be kept away from the crossing feature.

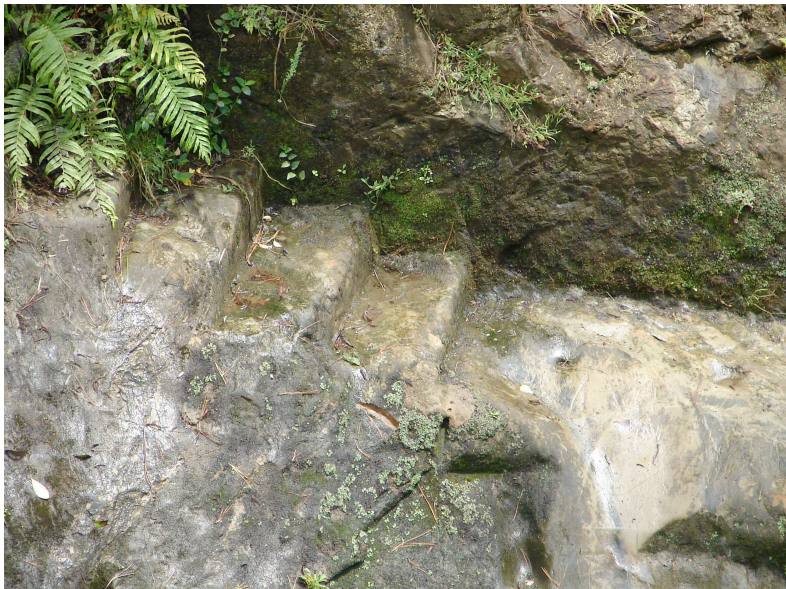
Plate 15. Steps on western bank below the waterfall.

- hh) Earth and vegetation should be removed from the cut channel and the channel maintained to keep it clear of debris.
- ii) Vegetation should be trimmed or kept clear of the step features so that they remain visible (this does not include the informal steps cut into the earth, as opposed to the bedrock created below the fall by people using the “mudslide”).

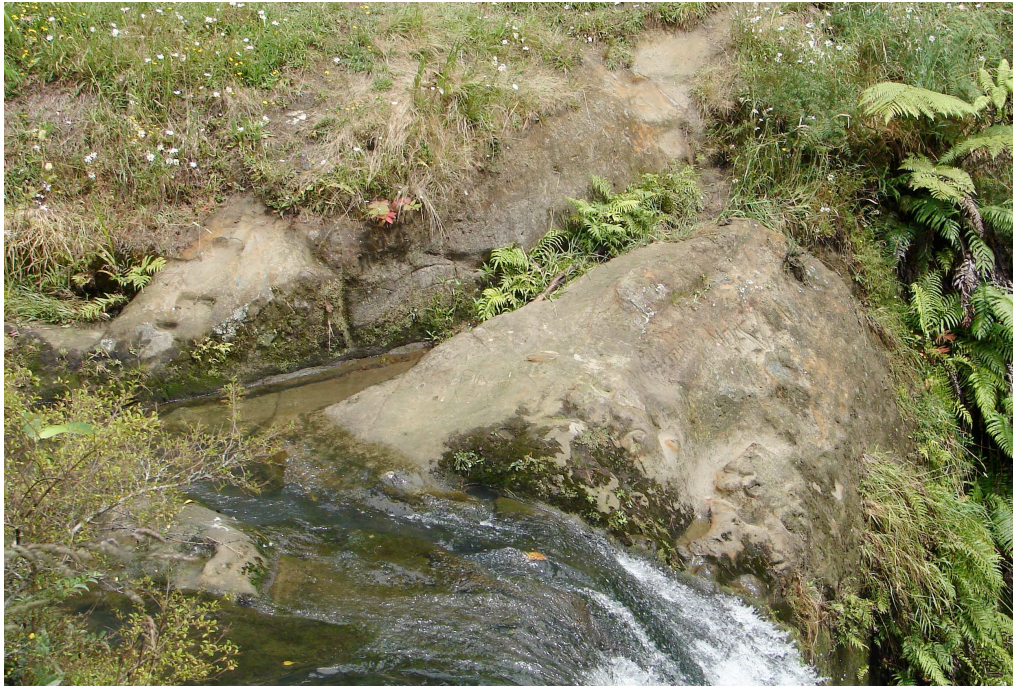
Plate 16. Western bank of waterfall with cut channel in bedrock visible with fern growing within it.

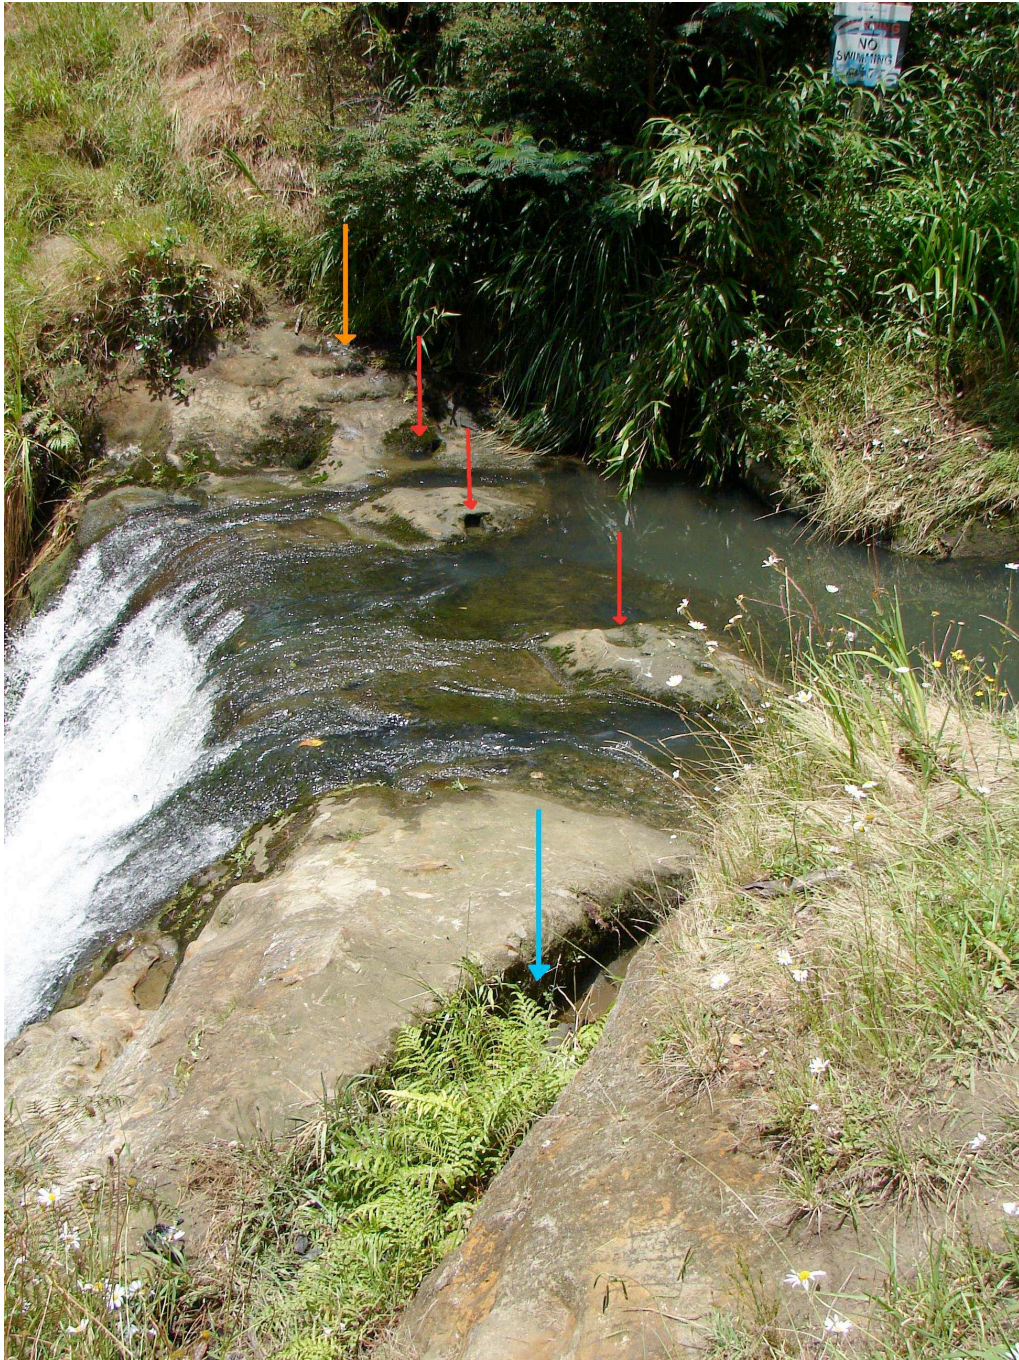
The other evidence of R11/2209 are the cuts in the bedrock above and below the falls. These include steps above and below the falls, posthole cuts across the top of the falls and a channel cut into the western side of the top of the falls to divert water around the side of the dam.

Plate 17. Top of waterfall with cut channel in bedrock visible with fern growing within it (blue arrow), cuts for posts across top of falls (red arrows) and steps cut into bedrock (orange arrow).
