Environmental Weed Control and Native Revegetation Programme for Oakley (Te Auaunga) Creek

FIRST EDITION 1995
REVISED EDITION MARCH 2009

On behalf of:
Auckland City Council

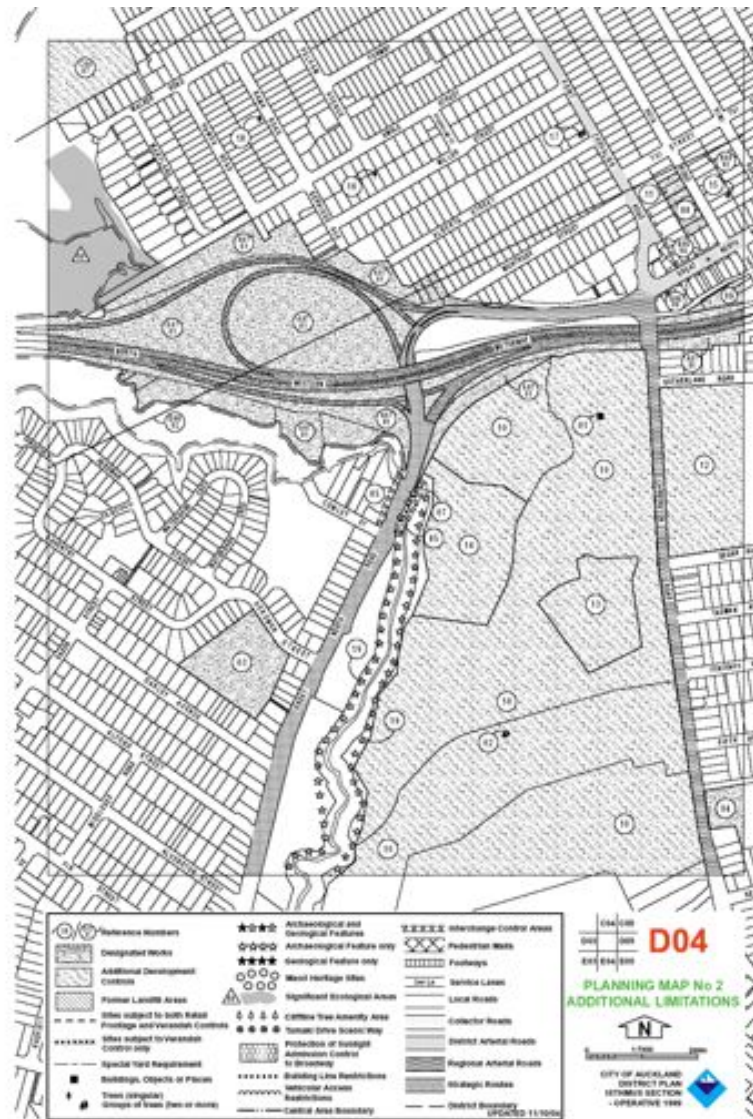
Appendix A: Planning Map D04, No. 2. Additional Limitations. (Taken from the City of Auckland District Plan Isthmus Section).

- D04-05: Interchange Control, Motorway Access. (See Rule 12.8.2.5 in district plan)
 D04-07: Building line for Road Widening, Great North Rd, east side 2.5m from road boundary. (Refer to Appendix B in District Plan).
 D04 -10: Concept Plan – Unitec. (Refer to Appendix B in District Plan).
 D04 –14: Concept Plan – Public Health Site, Mental Health Block, Carrington. (Refer to Appendix B).
 D04 – 19: Archaeological feature for protection: (From Appendix 3A - To east of Great North Road, south of North Western motorway, between Cowley Street and Fir Street. Maori habitation sites.

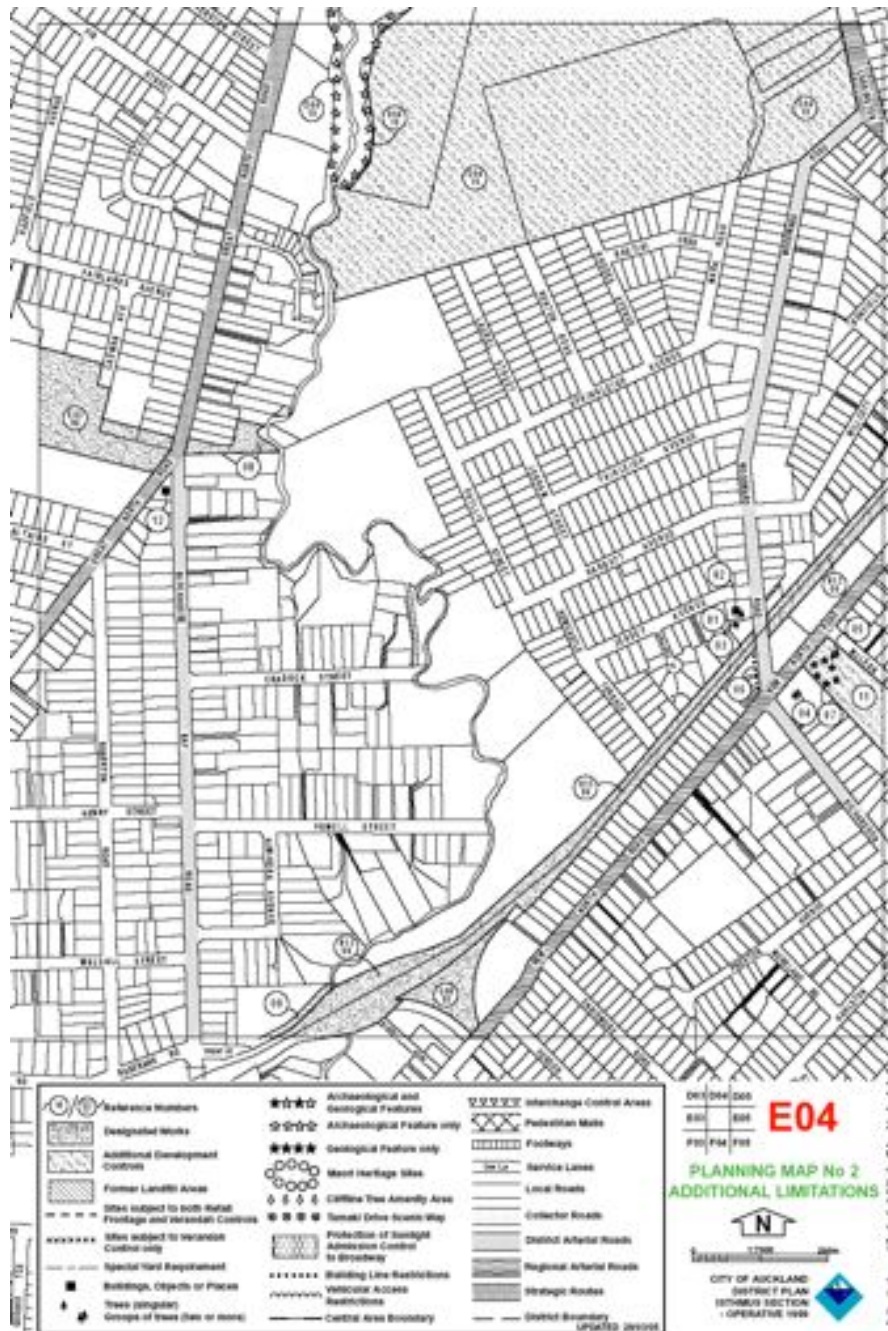
Appendix B: Planning Map E04, No. 2. Additional Limitations. (Taken from the City of Auckland District Plan Isthmus Section).

E04-08: Proposed reserve and accessway, 1628 Great north Rd/Oakley Creek.

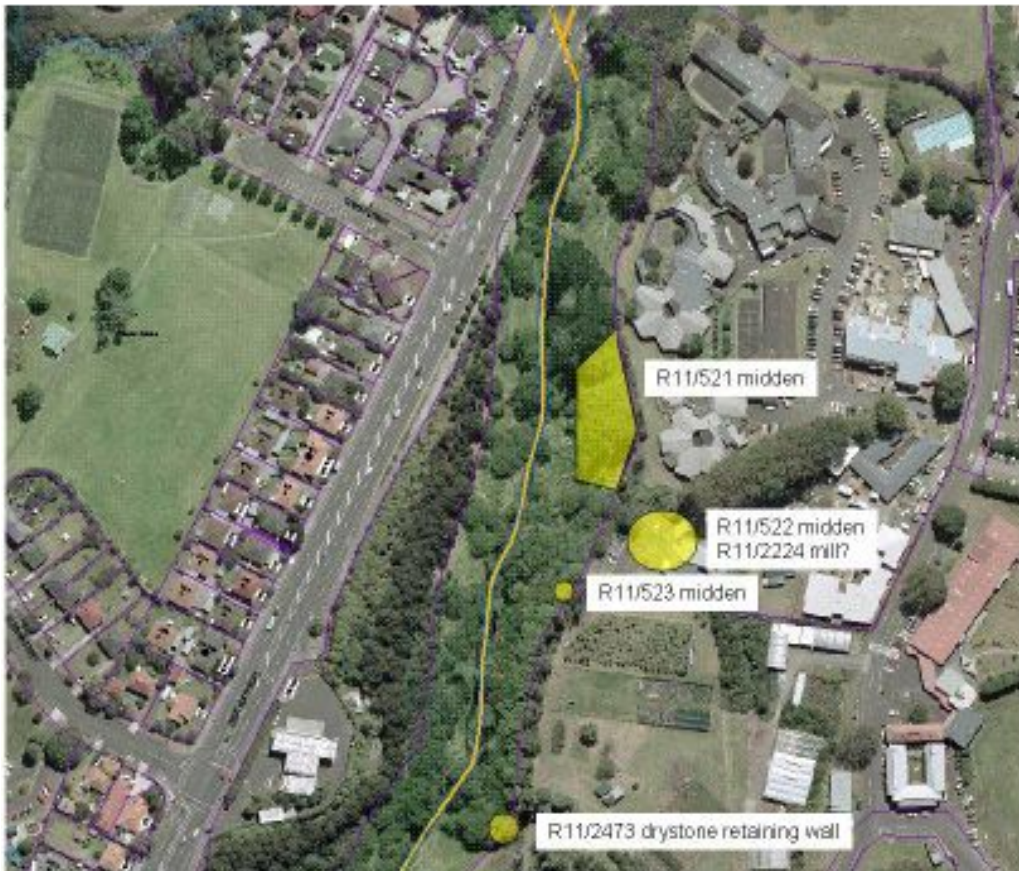
Figure 3 Recorded archaeological sites at the northern end of the Oakley Creek Revegetation Programme Area.

Midden from site R11/521 is readily visible spilling onto the path and on some of the slopes within this area, shell is found subsurface on the relatively flat banks above the slopes and is spread over a considerable area in the southern half of this management unit up to the Mason Clinic fenceline (refer Figure 3 – note limits shown on figure are approximate). It is also likely to be found within the clinic grounds as well, however this is not shown on the figure as the limits are unknown.

This sparse midden is likely to be larger than shown on Figure 3. All indications so far suggest that the site is concentrated where it is shown, however the earlier archaeological records suggest it was spread over a somewhat wider area than it is currently visible over, though all at the top of the bank. Therefore subsurface archaeological evidence is likely to be spread over a wider area than illustrated.

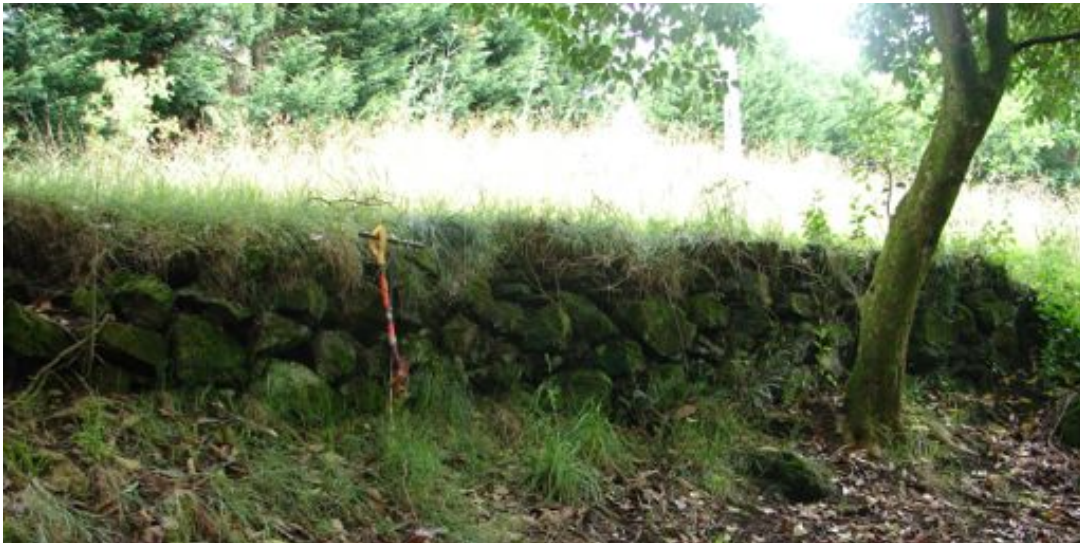
Currently this retaining wall is in good shape, however some trees are growing close to it. The area above it appears to still be used as an occasional vehicle track and is grassed.

Plate 9. R11/2473 illustrating close proximity of a tree.

- i) Trees close to this wall should be assessed as to whether their roots are likely to compromise the site, and removed if necessary.
- j) That the track above the wall is maintained as an occasional access route so that the wall is kept in its historical context.
- k) That the area above the wall is kept in grass, and should any items be planted below the wall they are planted so as not to obscure the wall from the path and R11/2373. Any trees planted in this vicinity should be done so at sufficient distance so their root systems do not interfere with the wall stability.

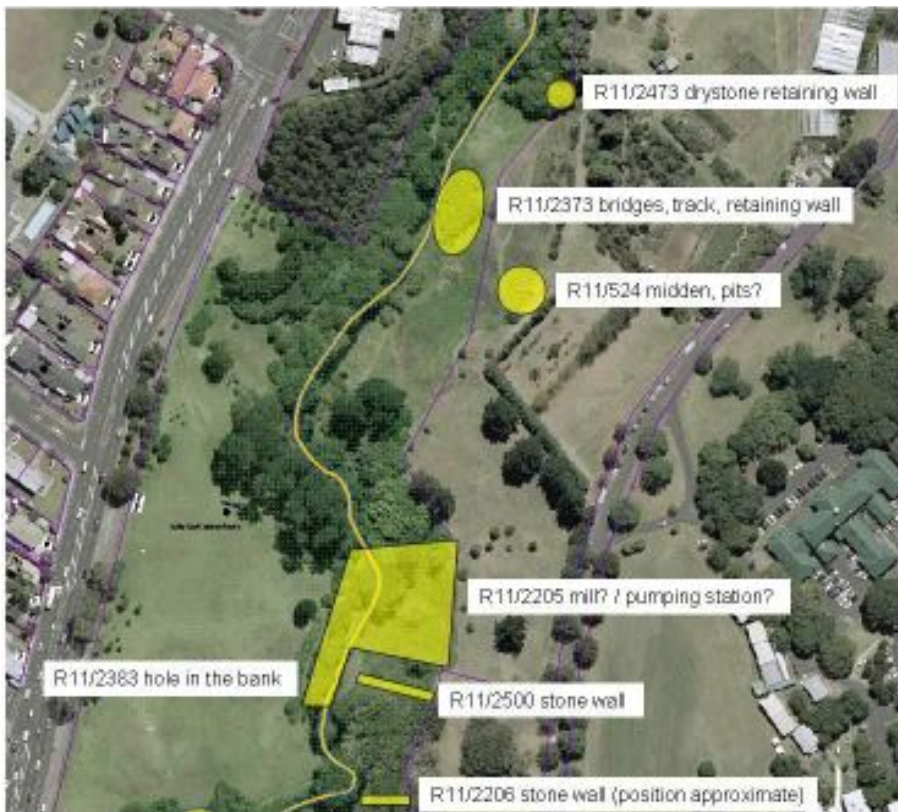
Figure 4. Archaeological site locations, Oakley Creek, Waterview.

This site (refer Figure 4 – the area marked is an indication only, the limits shown should be viewed as a minimum extent of the site) is outside the management area, however related community planting has occurred on it and maybe ongoing. All community plantings should cease in this area. An Authority to modify an archaeological site should be sought if planting is to continue. Some of the plantings, if they are of trees with large root systems should be reviewed. I note that as it lies outside the area addressed by Habgood (2005) it maybe necessary to establish who has ownership of the land here and what body should take responsibility for its implementation.

The location (refer Figures 4 and 5) of this is the most approximate of the sites illustrated on the locational figures, as its location is not readily visible on

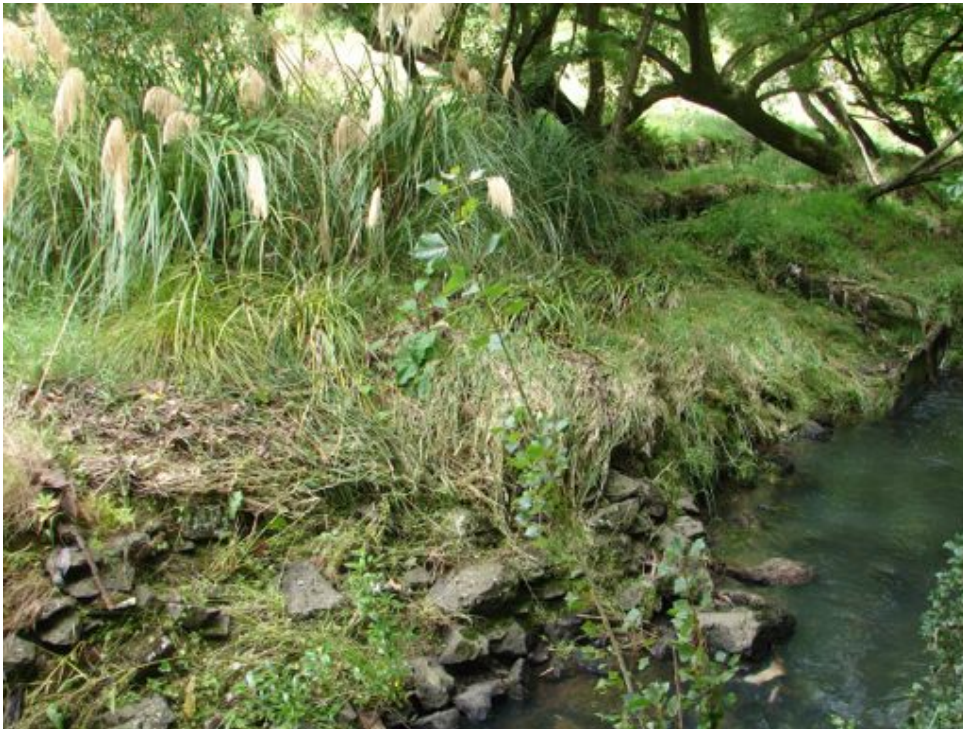
This site is compromised by both recent and historic plantings, and/or self sown plants. Some of these plants should be removed to ensure that they don't further compromise structure stability.

Plate 10. Toetoe above the stone bridge foundations, willows (background) over approach track to bridge, eastern side, these should be removed.

- l) That vegetation (other than grass) is removed from above or adjacent to the stone structures. This includes the toe on the western bank. Their removal could be mitigated by planting the creek bank (within 500mm where adjacent to the site) where stone and other works aren't present in the immediate vicinity.
- m) That the willows and recently planted seedlings are removed from the track below the retaining wall so that the site historical context is retained. The area surrounding the site (on the eastern side of Oakley Creek) should be maintained as open space and in mown grass to assist in illustrating its past farming context. No more plantings should occur in this vicinity (creek banks excepted).

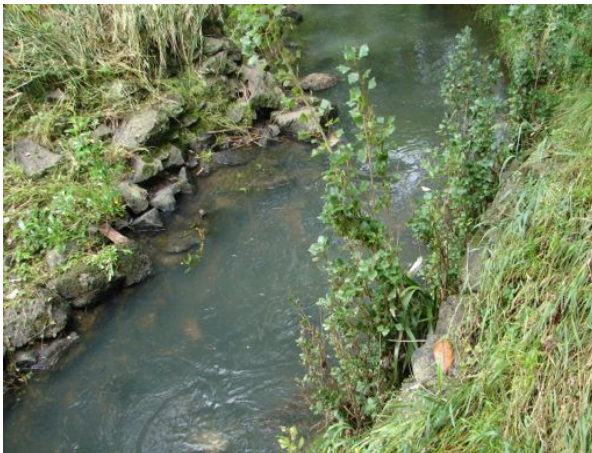
Plate 11. New growth from the poplar amongst stone bridge foundations, R11/2373.

- n) That the poplar on the western side of the creek is retained, it is of some age and is clearly part of the historical plantings related to the site, however new growth should be routinely trimmed so that it does not further damage the bridge foundations that it is already partially growing over.

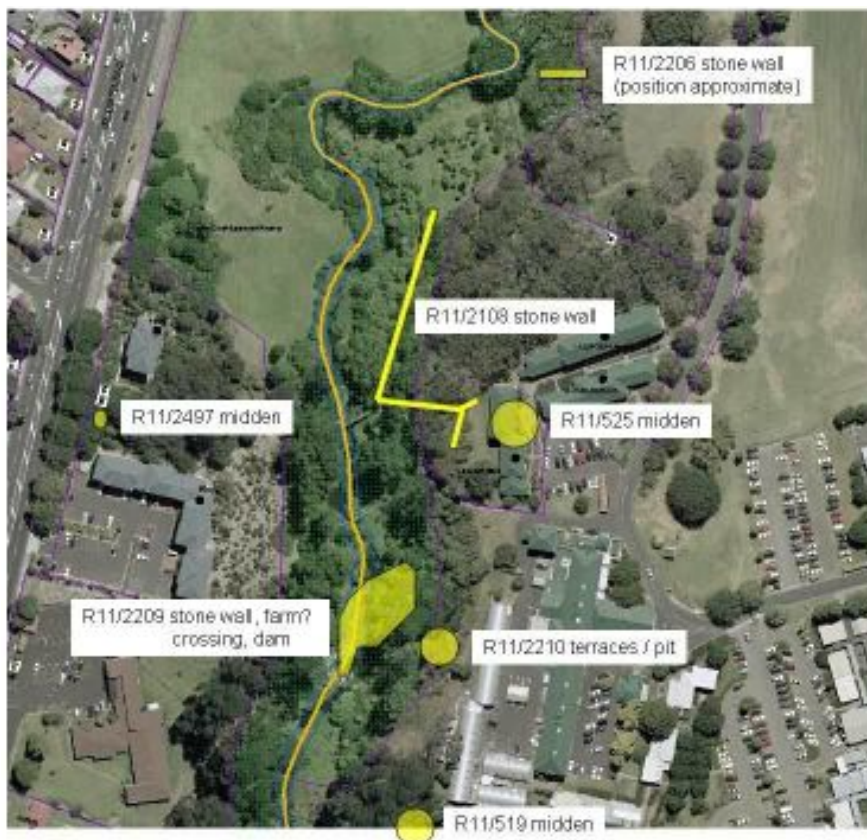
Figure 5. Archaeological site locations, in the vicinity of the waterfall and walkway access between Unitec and Great South Road.

The pit is well defined, however the terraces are more difficult to define as vegetation, including fallen trees obscure the ground surface in this vicinity. Whereas the terrace that the pit is located upon is almost definitely real, it cannot be certain that the other is. It may be a result of slumping, part of an old track (as it appears to slope towards the old tracks south of the waterfall or possibly caused by past tree falls). Planting has occurred in this vicinity, though none are close to the pit. The area marked on Figure 5 should be looked upon as indicative only, it maybe slightly further west than shown.

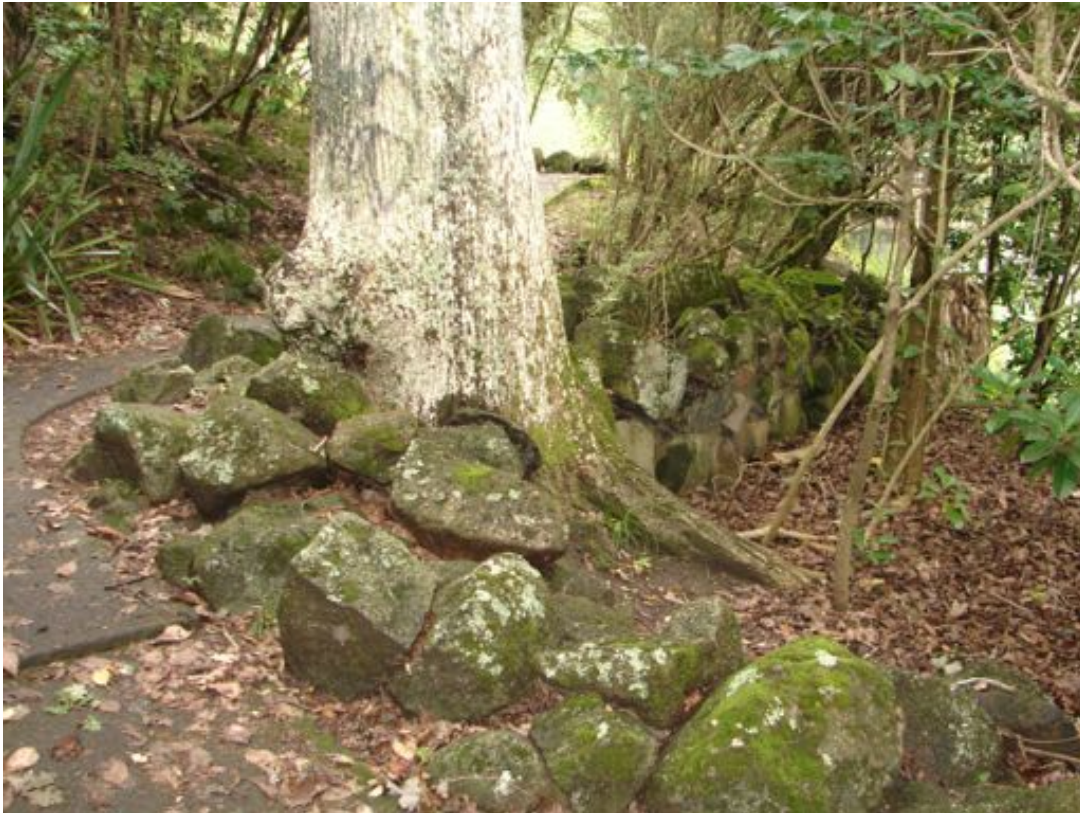
This drystone wall is adjacent to, and has the walkway pass through it, and is generally in good condition. There are a number of trees growing adjacent to

and on/over it, these trees are of a vast variation in age and size and likely to have varying effects upon the structural integrity of the wall.

Plate 12. Large historic planting amongst the stones of R11/2108 near the southern end. This tree should not be removed as it is part of the history of the site, however other smaller trees that may also grow to such proportions should be removed if they threaten the integrity of the wall.

- bb) Unsuitable trees or plants with large root structure should be removed from the near vicinity of the wall.
- cc) Active maintenance of the site should occur, removing any self sown seedlings (unless they are of a suitable species).
- dd) As it is an area (management unit 5) where active revegetation is taking place, all community groups working in this area should be made aware of the walls historical significance and any plantings near the wall should only be of species with small root systems.

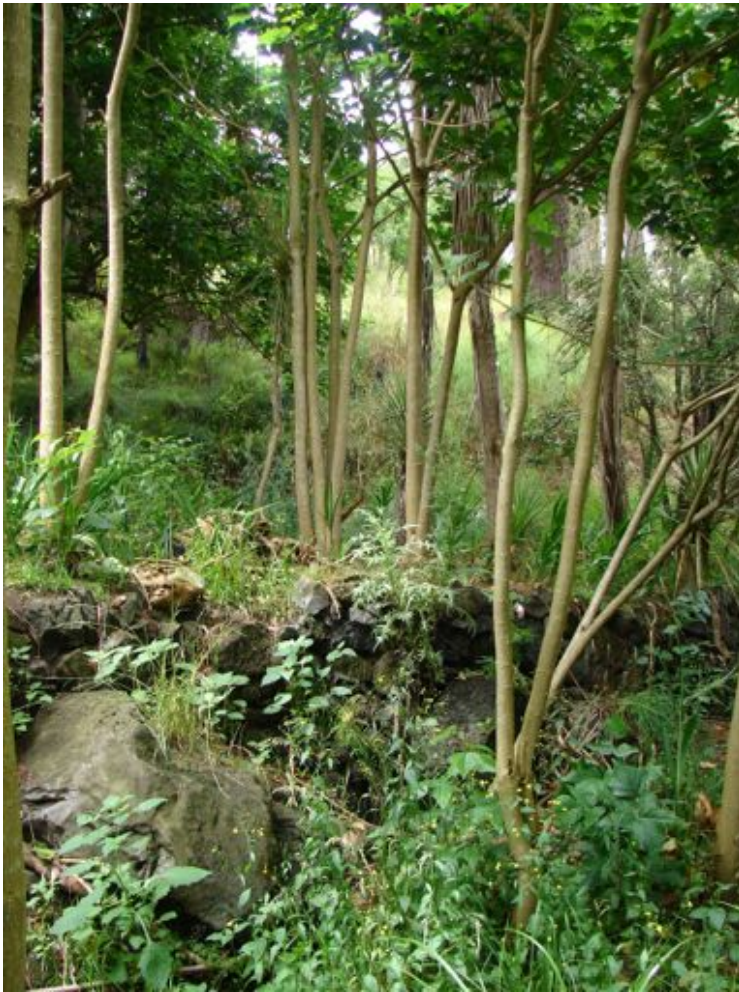
The stone wall acts as a retaining wall, back from the eastern bank of Oakley Creek, it is of drystone construction and has recent and semi-distant past plantings in its general vicinity. Many of these appear to be of large specie trees, Plane and Puriri, and may not be suitable, for the continued structural integrity of the wall to be situated here.

Plate 13. Young saplings growing in close proximity to the drystone retaining wall.

- ee) Trees growing near the wall should be audited for suitability. Trees that are, or are likely to damage the structural integrity of the wall should be removed and their root systems allowed to rot in place. Species of plants that may regrow from the roots should be poisoned.
- ff) Active maintenance of the site should occur, removing any self sown seedlings (unless they are of a suitable species). Replacement trees could be planted within the vicinity as long as they are unlikely to cause future structural damage to the wall.

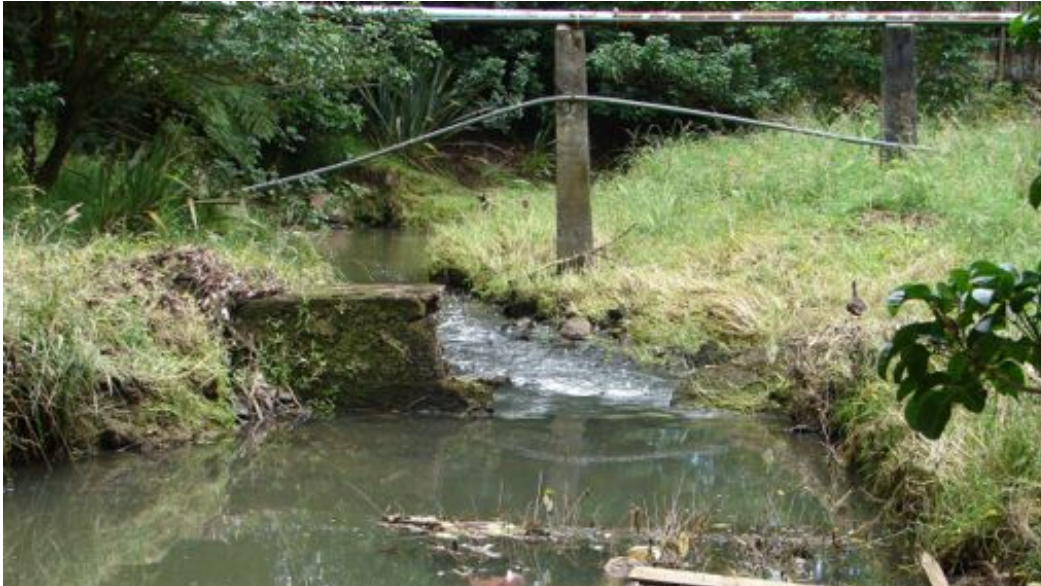
On both sides of the creek the remains of a structure, presumably a rudimentary crossing are present (another possibility is that it was a dam – refer view in Plate 14). Those remains on the western side are in a better state of preservation than those on the east. This structure is unlikely to pre-date 1900, and therefore would not qualify as an archaeological site under the Historic Places Act legislation. It is not so clear whether it could be defined as an archaeological site under the Resource Management Act, which legislates to protect archaeological sites but does not define them. Nevertheless I believe it should be retained as it is a rare historic artefact in the urban setting that illustrates the make do, no 8 wire mentality that New Zealand farmers have been credited with.

Plate 14. Remains of the crossing (dam?), showing relatively intact western side, the eastern side is discernibly collapsed on the right.

gg) Creekside plantings should be kept away from the crossing feature.

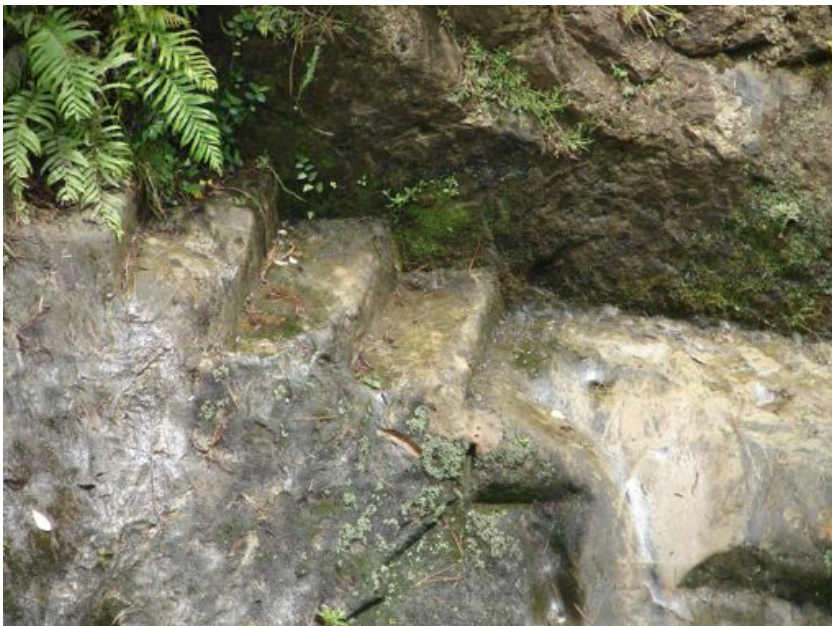
The other evidence of R11/2209 are the cuts in the bedrock above and below the falls. These include steps above and below the falls, posthole cuts across the top of the falls and a channel cut into the western side of the top of the falls to divert water around the side of the dam.

Plate 15. Steps on western bank below the waterfall.

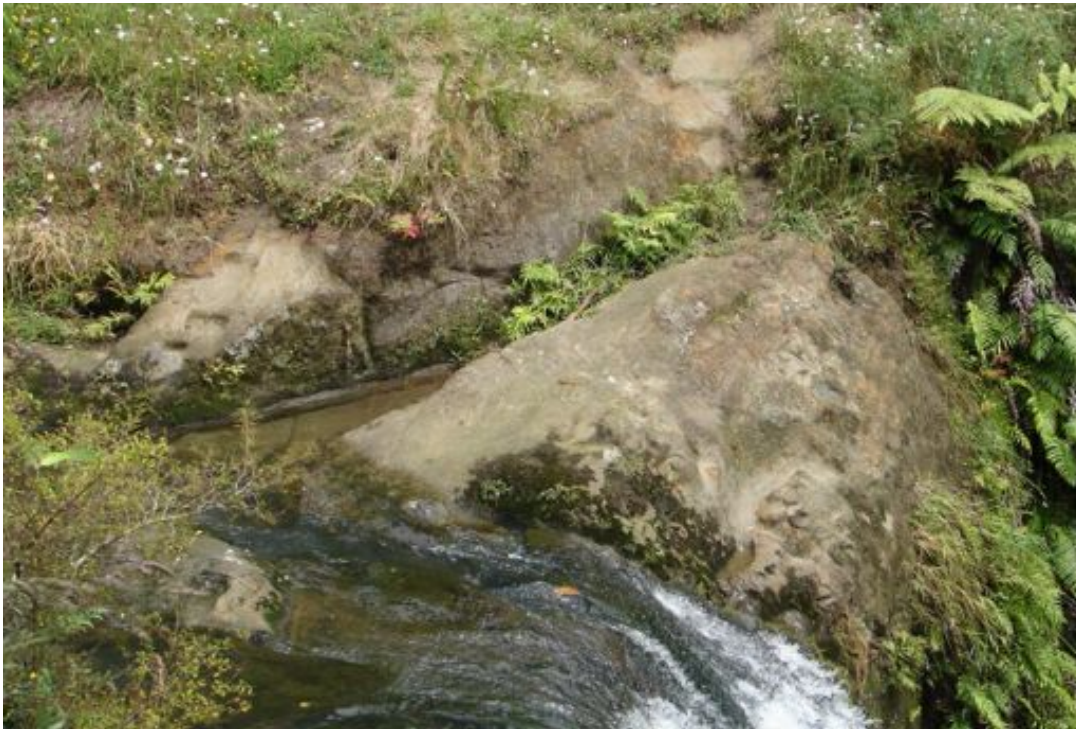
Plate 16. Western bank of waterfall with cut channel in bedrock visible with fern growing within it.

- hh) Earth and vegetation should be removed from the cut channel and the channel maintained to keep it clear of debris.
- ii) Vegetation should be trimmed or kept clear of the step features so that they remain visible (this does not include the informal steps cut into the earth, as opposed to the bedrock created below the fall by people using the “mudslide”).

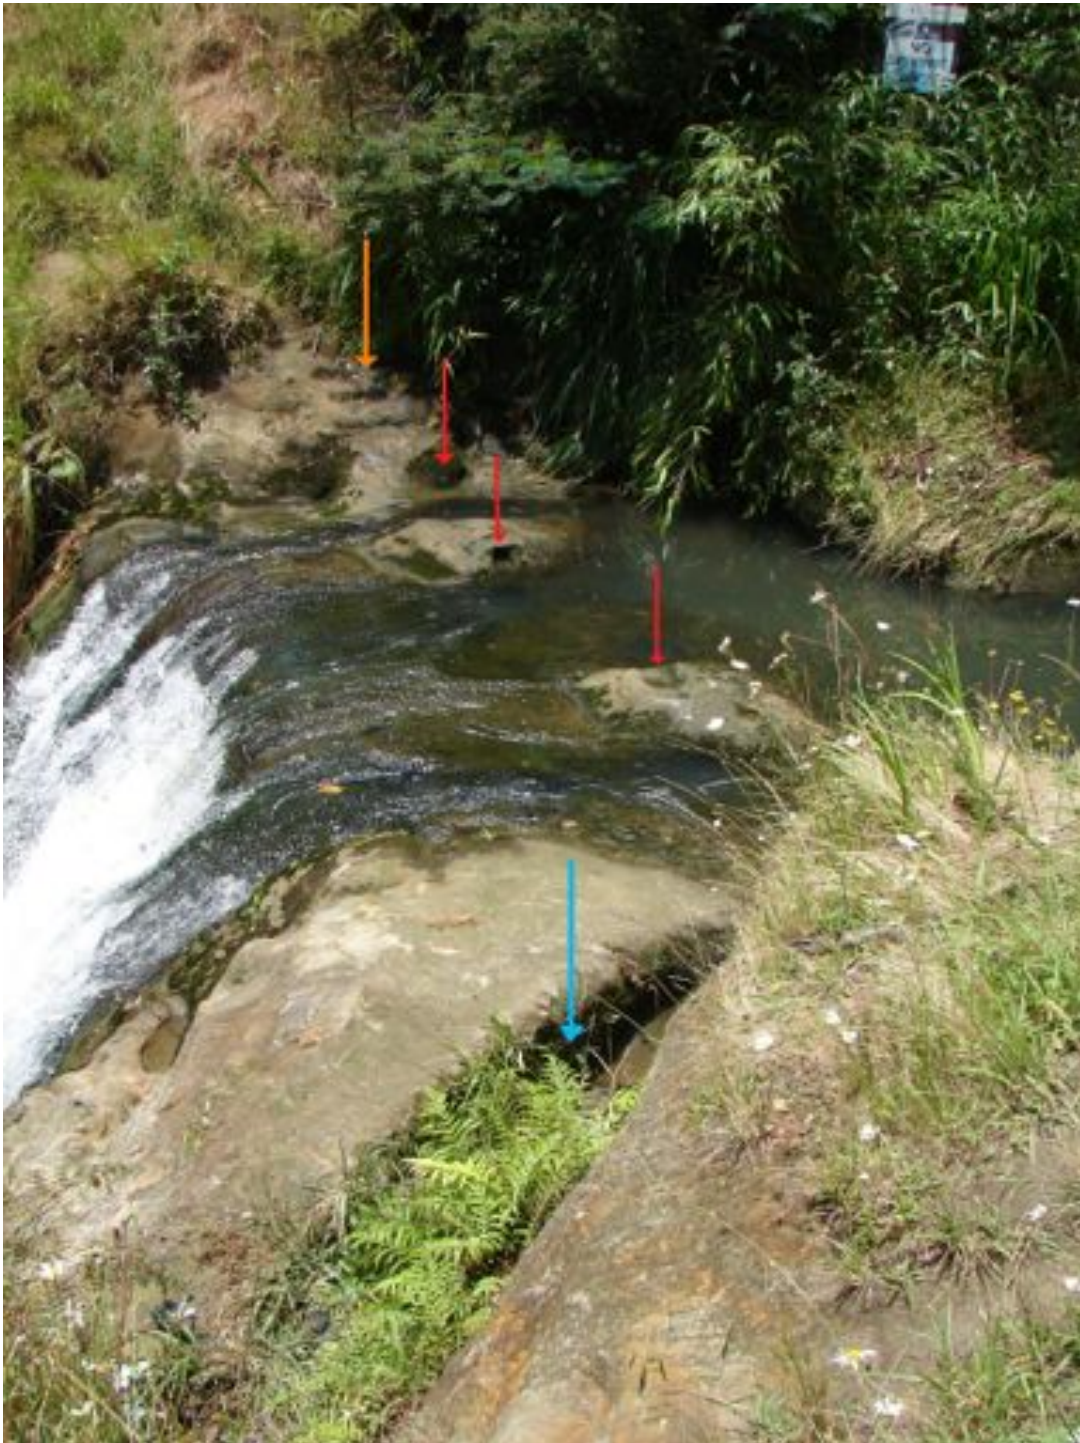
Plate 17. Top of waterfall with cut channel in bedrock visible with fern growing within it (blue arrow), cuts for posts across top of falls (red arrows) and steps cut into bedrock (orange arrow).

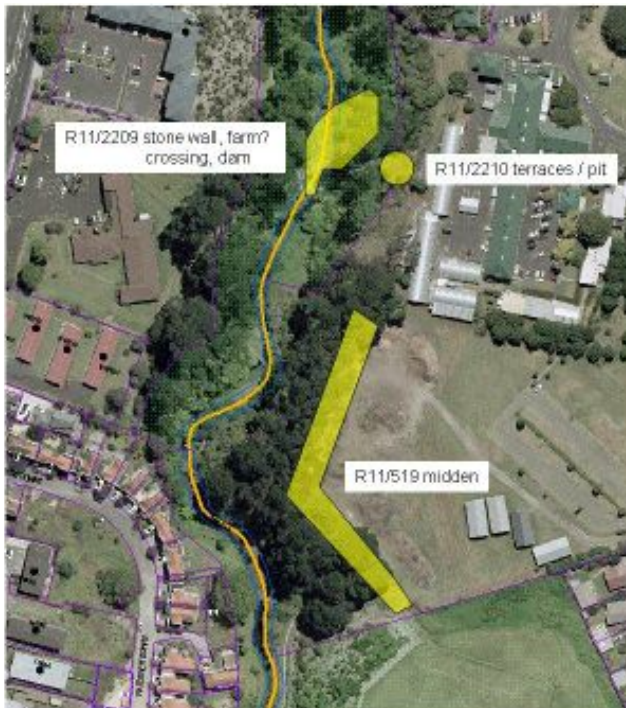
Figure 6. Archaeological site locations adjacent to Management Unit 7.

The long midden site R11/519 is located beneath and adjacent to the pines on the Unitec grounds to the east of MU 7 (Figure 6.) Probing and visual survey indicates that this midden is confined to the top of the bank and the first 3m below it (occasional slopewash individual shells excepted). No archaeological evidence was found within the Management Unit. It is understood however that outside the boundaries of the MU, volunteers are planting higher on the banks and should they continue planting towards the top of the bank they may encounter archaeological evidence.

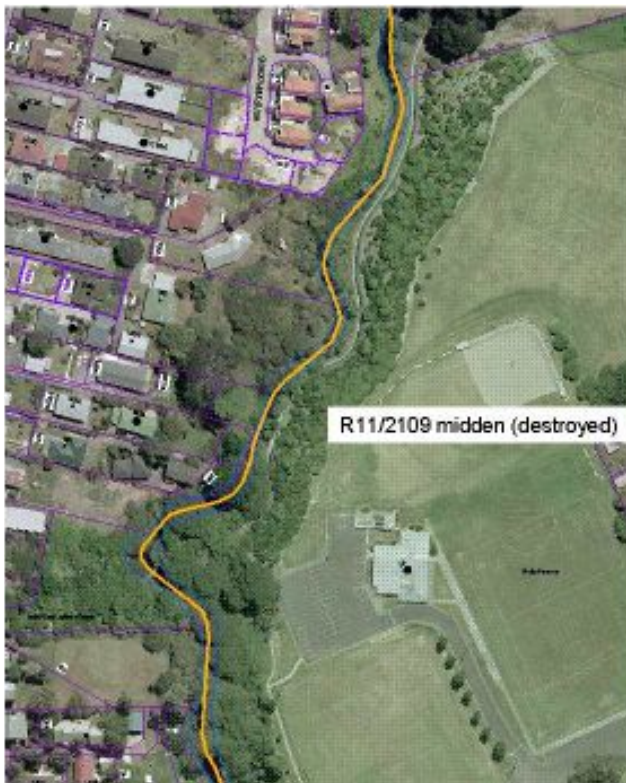
Figure 7. Locations of destroyed site R11/2109 adjacent to Management Unit 7.

Further along the walkway, beneath the Albie Turner Fields (refer figure 7), R11/2109 has been recorded. This site may have been a continuation of R11/519, however it has been destroyed by past quarrying, landfill and other earthworks activities. It is extremely unlikely that any intact deposits relating to this site have survived. It should not be viewed as an archaeological constraint.

No archaeological sites have been recorded within these management units, however evidence of both Maori occupation (R11/2109 and R11/2248) and historic farming practices (R11/2208) have been recorded nearby (Figures 7 and 8). No archaeological evidence has been found on or immediately adjacent to the walkways and grassed areas, or Oakley Creek itself. All of the vegetated banks in these management units are steep, and in places impossible to adequately survey. It would appear unlikely, but possible that archaeological evidence maybe found on these slopes, the most likely being midden deposits thrown down the slopes. It is therefore recommended that;

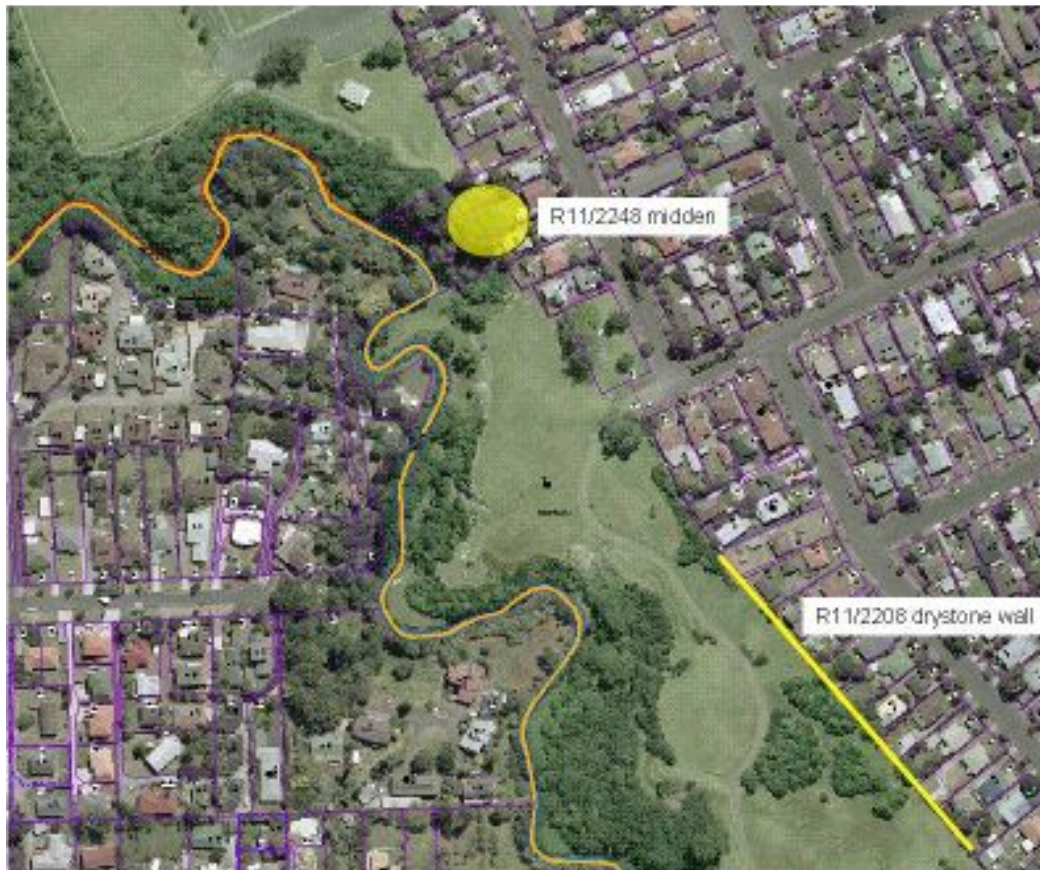
Figure 8. Archaeological sites recorded in the vicinity of Management Units 8 and 9.
