**Oakley Creek Te Auaunga  
Ecological Restoration Plan**

**2015-2025**

July 2015 - Final

Prepared on behalf of: Auckland Council

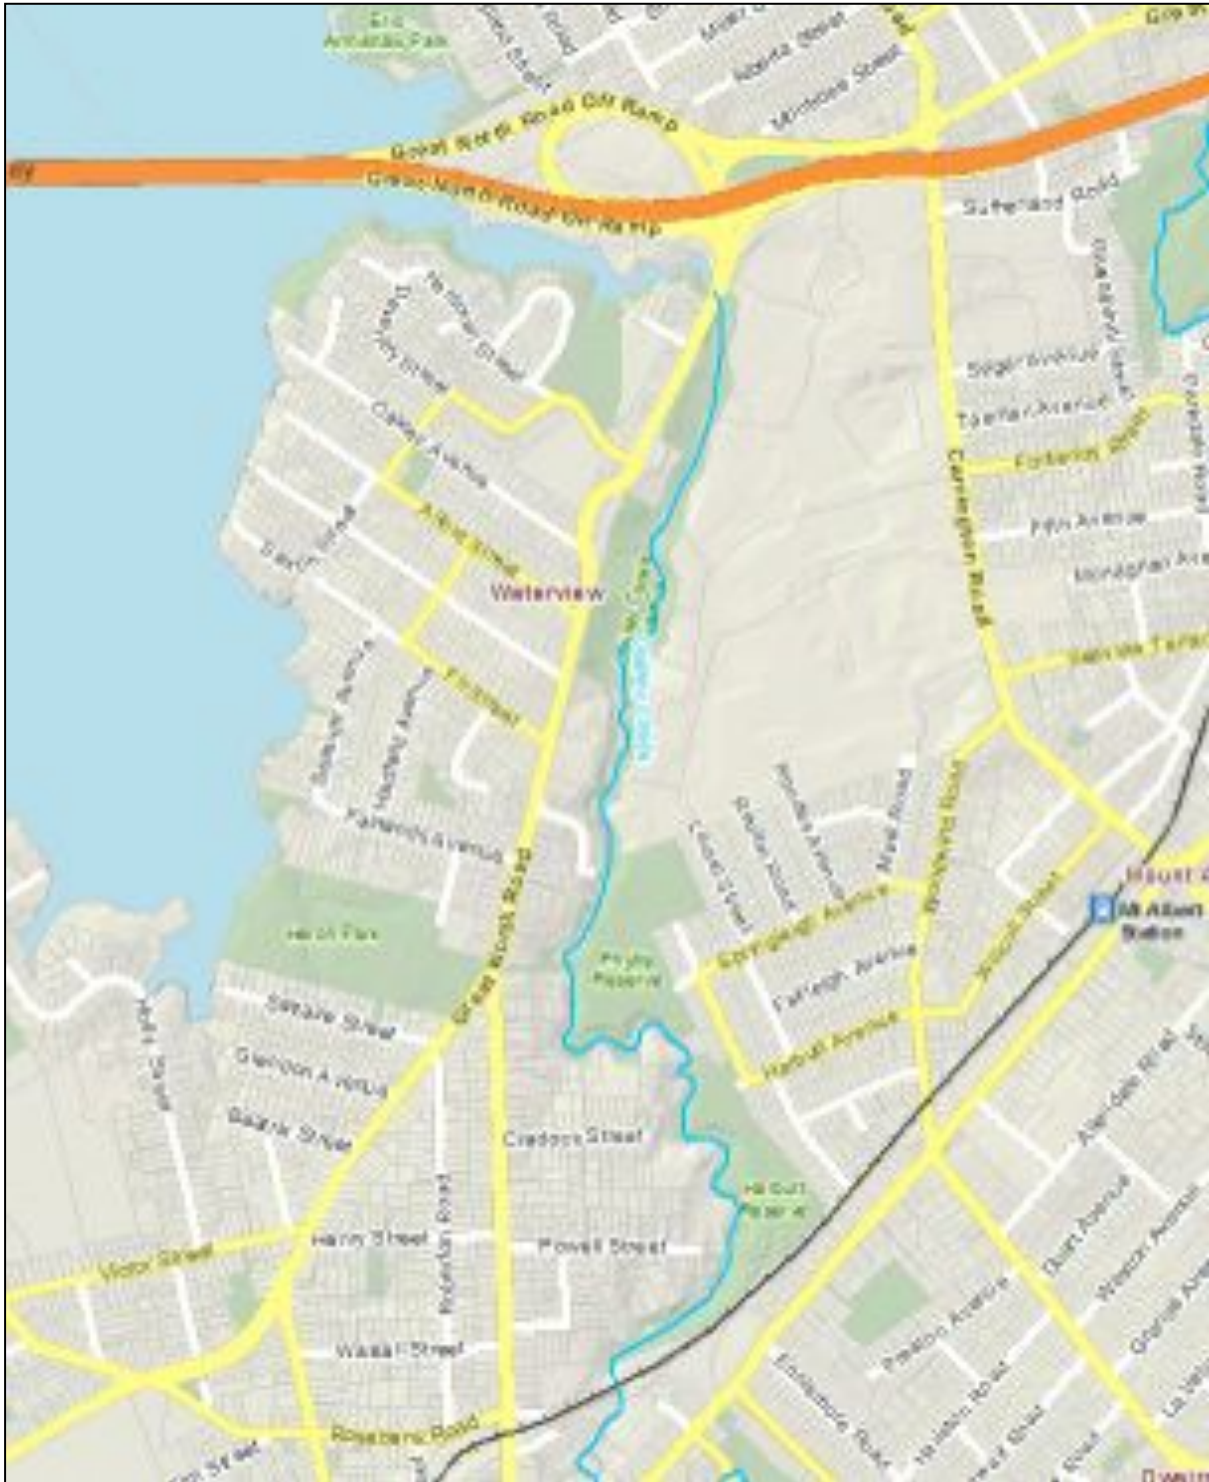
Figure 1. Site location map for the Oakley Creek restoration work area (Great North Road to end of Harbutt Reserve)

This Ecological Restoration Plan and programme of work covers the section of Oakley Creek in the lower reaches, where it flows along the Oakley Creek Walkway and through Phyllis and Harbutt Reserves. The project area is bordered by Great North Road in the north, Unitec Institute of Technology (Unitec) in the east and residential areas around to the west. The southern boundary is at the south-western end of Harbutt Reserve parallel with the western railway line. See Figure 1 for a location map.

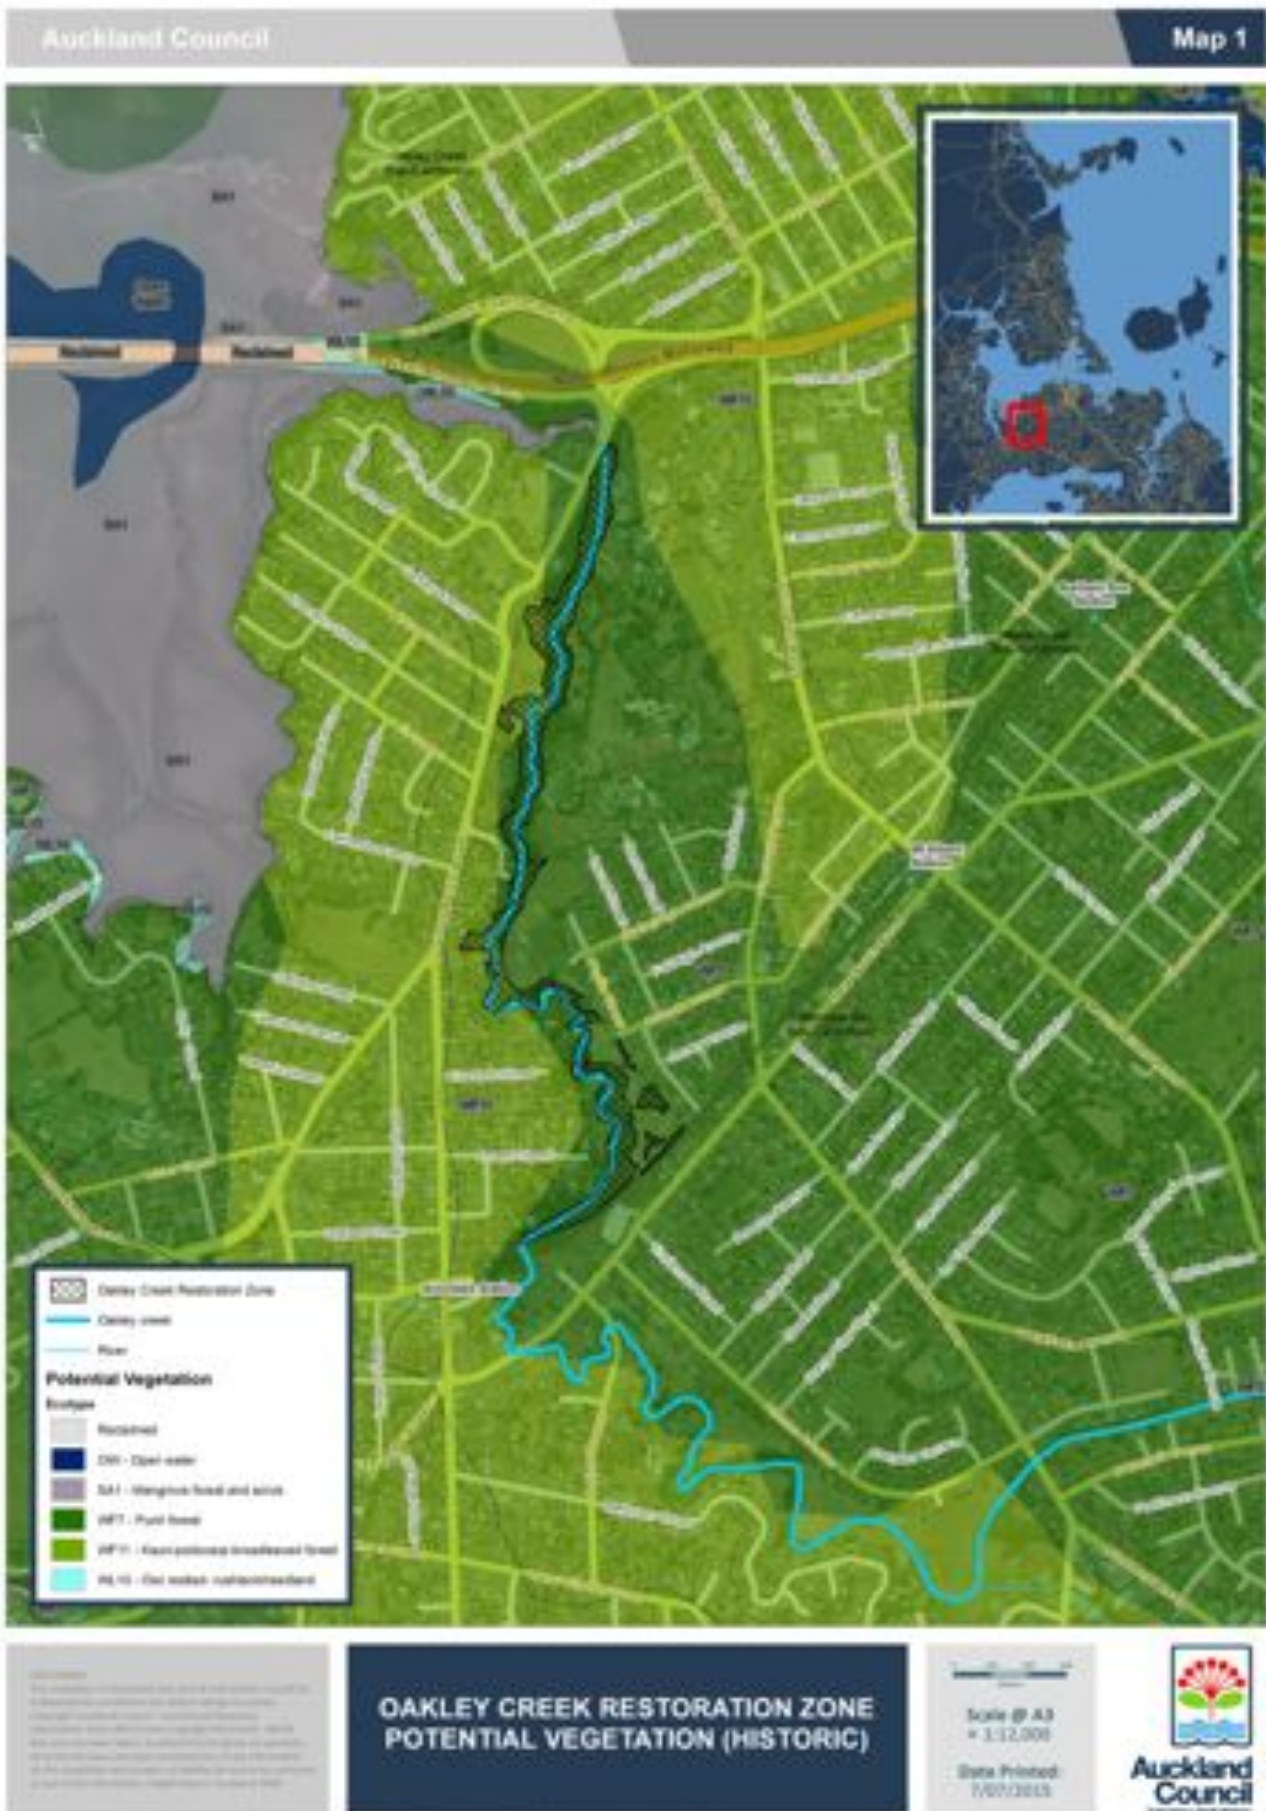
Figure 2. Oakley Creek potential vegetation (historic) – provided by Auckland Council

Aerial photos from the 1940s show that the upper reaches were relatively open with scattered specimen trees along the banks and the surrounding land use as farming and some residential housing. The southern part of the creek was more densely vegetated. There are earthworks apparent at Phyllis Street Reserve and at the end of Harbutt Avenue in these images. These earthworks are the Phyllis Street Closed Landfill site, which has had remedial works carried out between 1999 and 2002, including clay capping and stormwater management improvements (Andrew Stewart, 2015). On the eastern slope of Management Unit 8 there is still evidence of a refuse tip, with old bottles and metal present (some of which was removed in 2014). The exact extent of landfill in Harbutt Reserve is unclear, but is from site observations suspected to be the upper flat areas and some of the regraded slopes in MU 9 and MU 10.

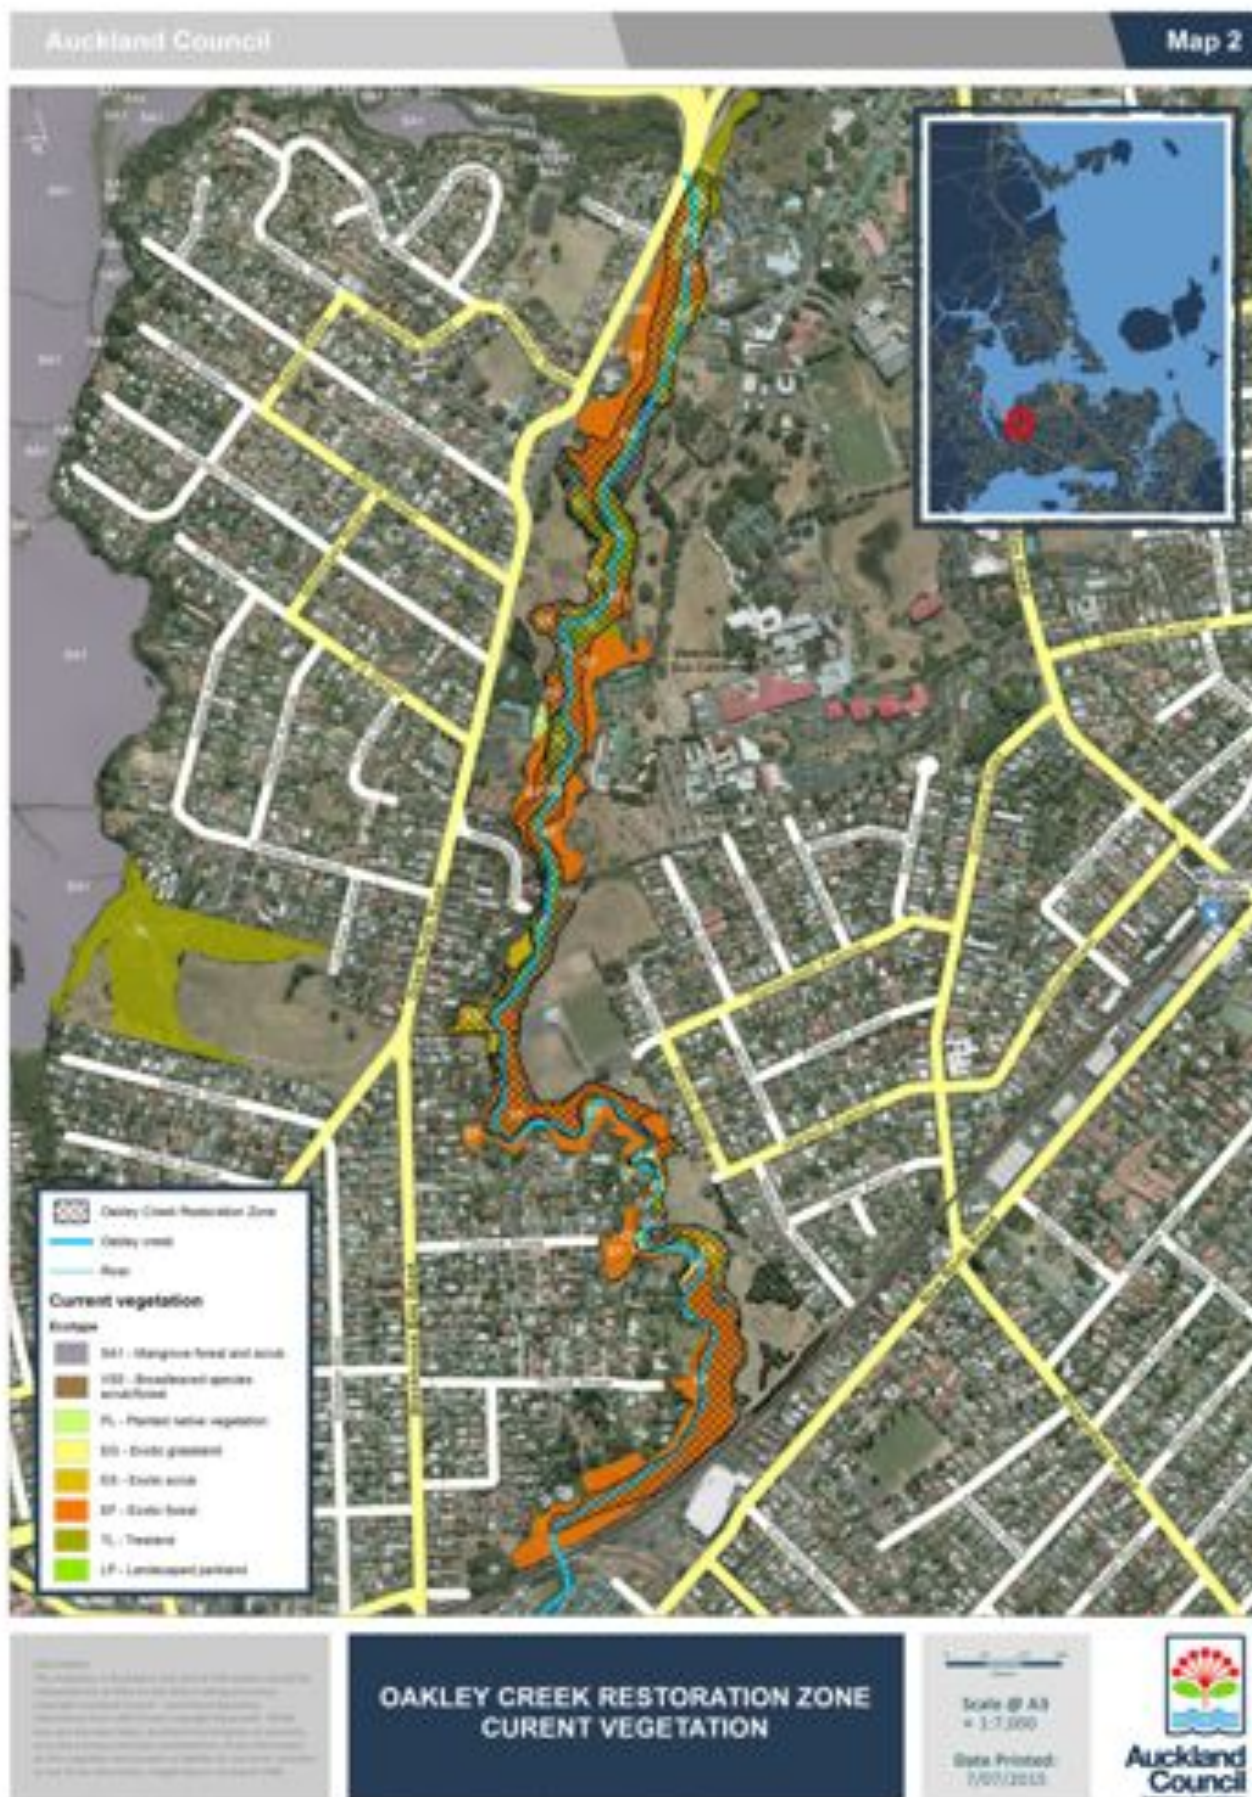
Figure 3. Oakley Creek current vegetation map – provided by Auckland Council

The six areas of mahoe rock forest at Oakley Creek vary in character, but mahoe forms a generally dominant or abundant canopy component with mature houhere, kanuka, puriri, karaka, mapou, ponga, lemonwood and cabbage tree also present in varying amounts in the canopy. The sub-canopy is generally relatively sparse with a mix of mapou, hangehange, karaka, lemonwood, mahoe, pigeonwood, karamu, houhere and ponga present. Native seedlings include karaka, mapou, mahoe, pigeonwood and karo.

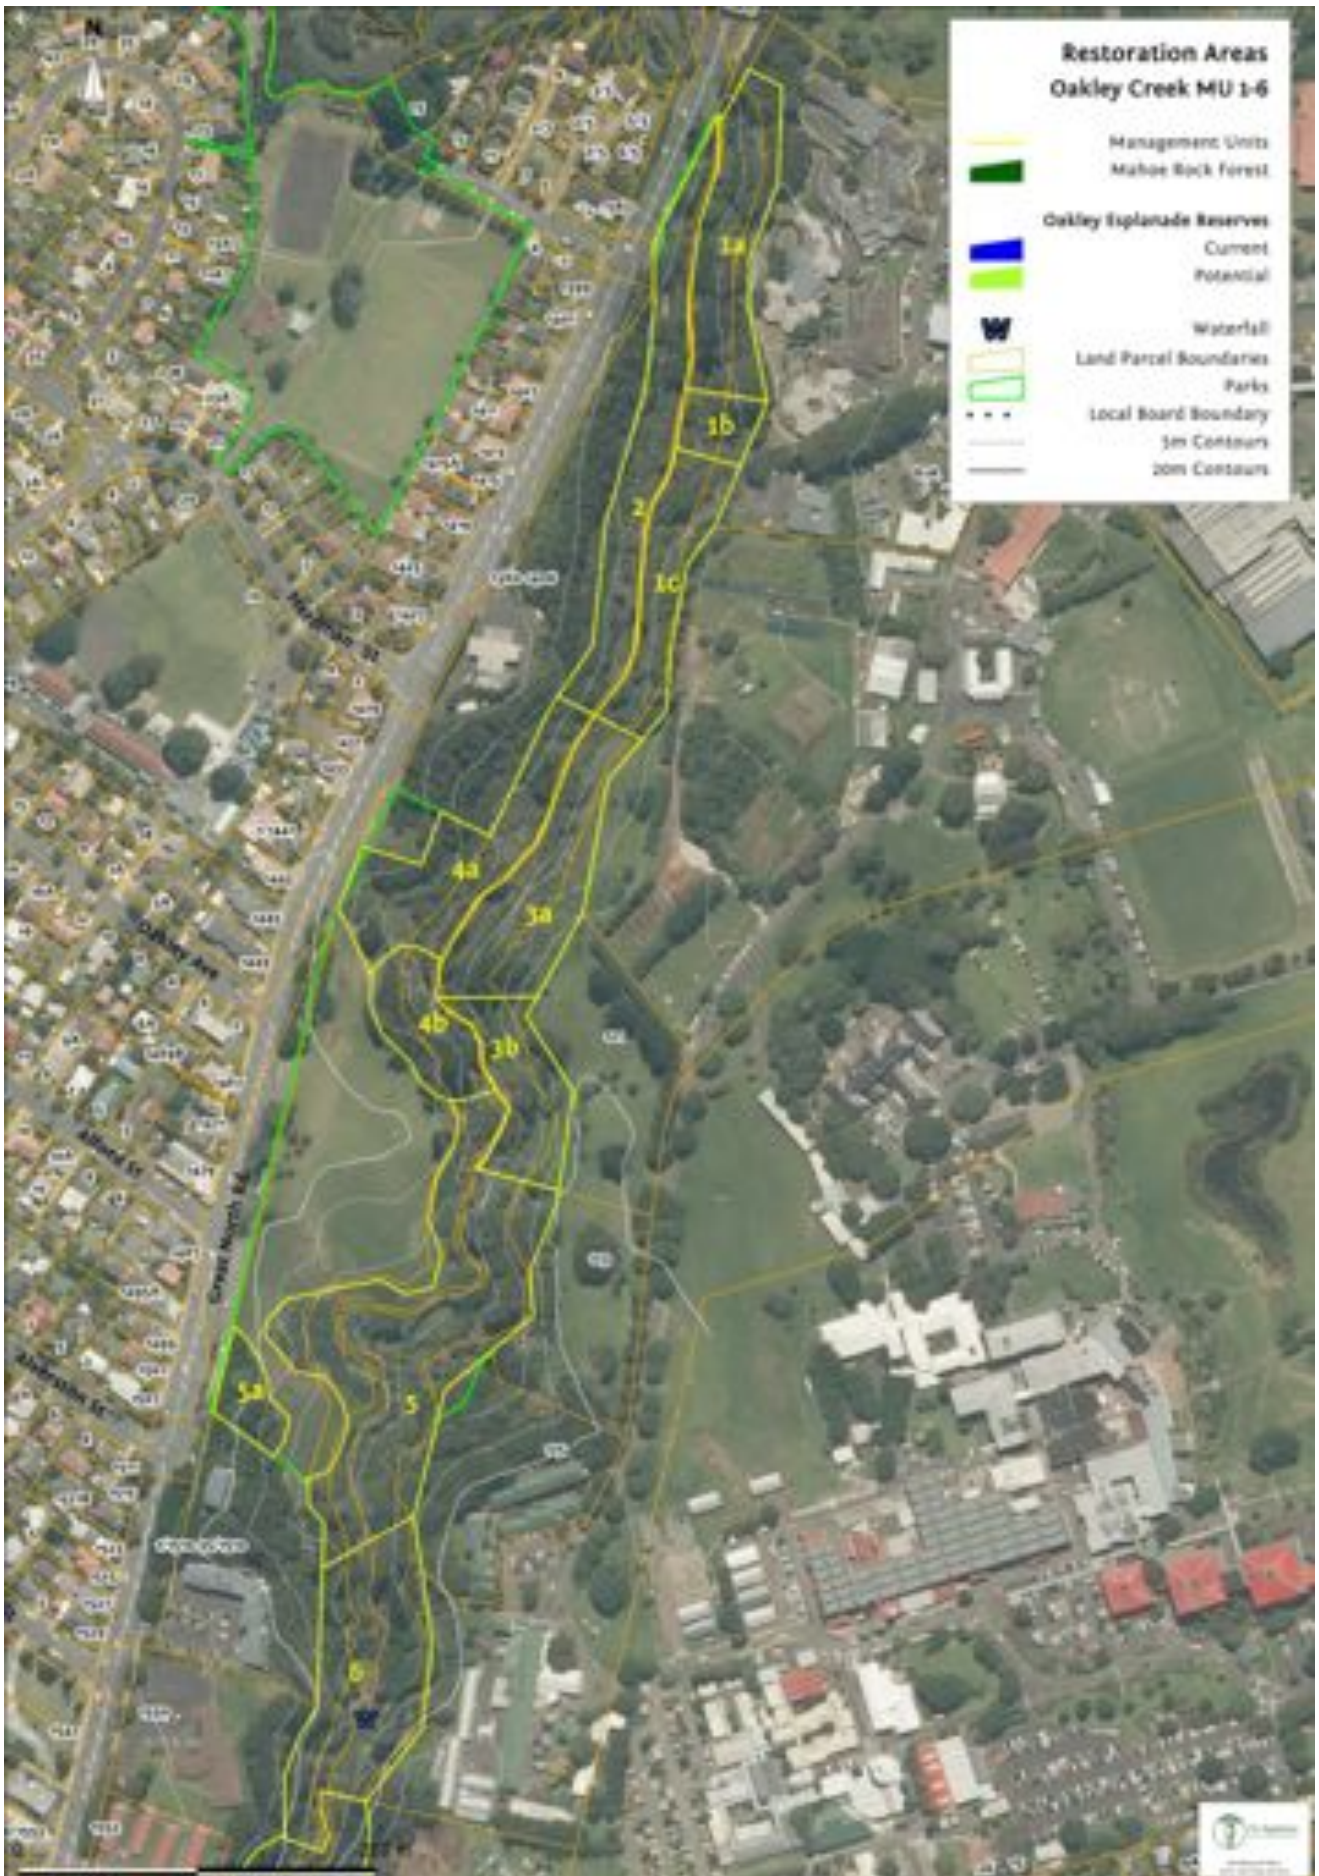
Figure 7. Oakley Creek restoration work area MU 1-6

Management Units for Oakley Creek are depicted in Figure 7 and Figure 8. When planning restoration tasks archaeological sites identified by Druskovich (various reports, and to be updated in winter 2015 survey) need to be taken into account.

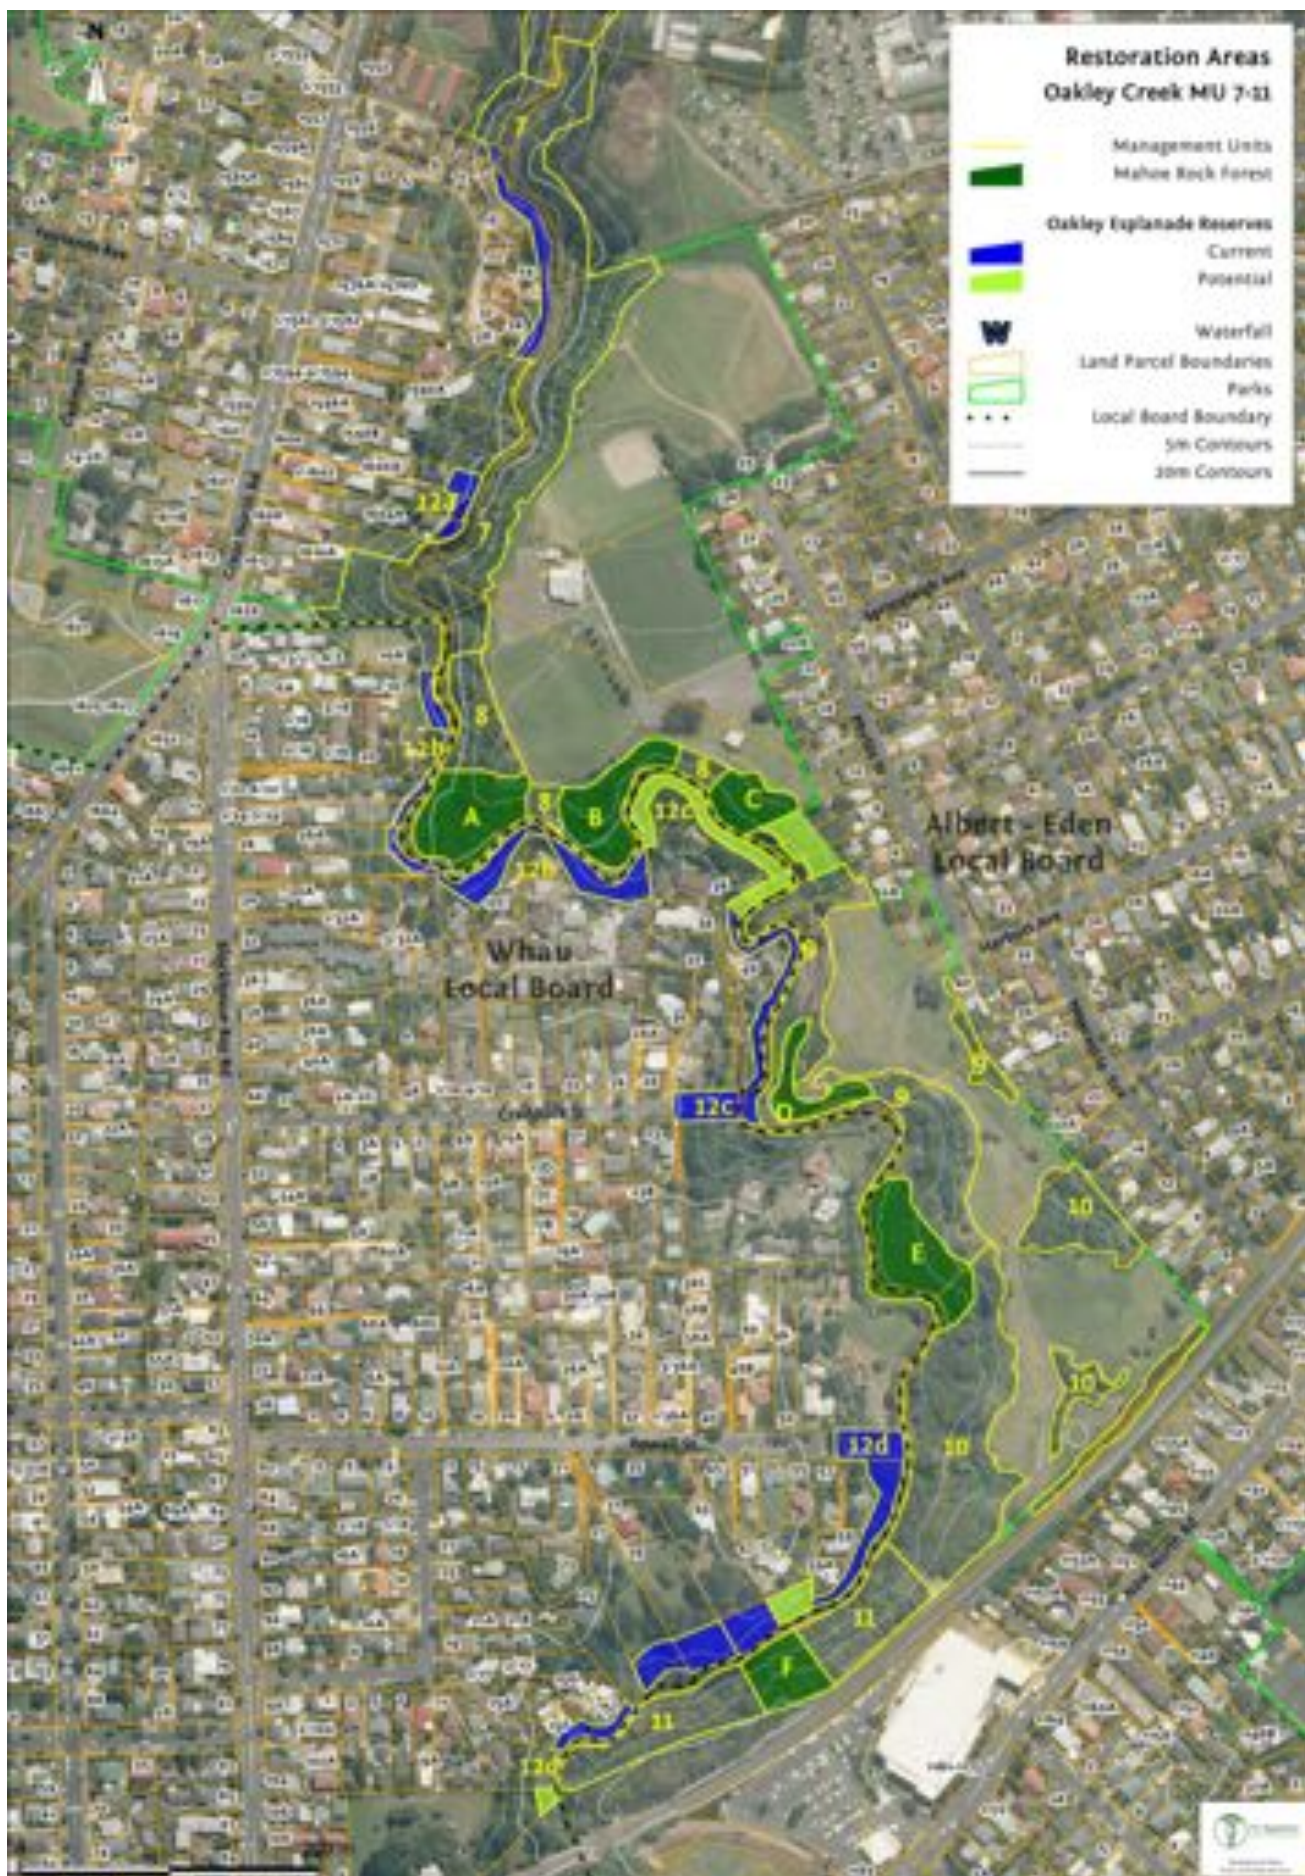
Figure 8. Oakley Creek restoration work area MU 7-12

Management Unit Twelve has been added as part of this new restoration plan and encompasses the esplanade reserves on the western banks (owned by Auckland Council). These esplanade reserves have been divided into MU 12 a, b, c and d, as can be seen in Figure 8. Areas that have been vested to Auckland Council are shown in blue. Potential esplanade reserves, shown in light green, are expected to be transferred to Auckland Council in due course through consenting processes or change of ownership (for example due to subdivision, shared path works). MU 12 b-d are within the Whau Local Board area, whilst MU 12 a is in the Albert-Eden Local Board area.

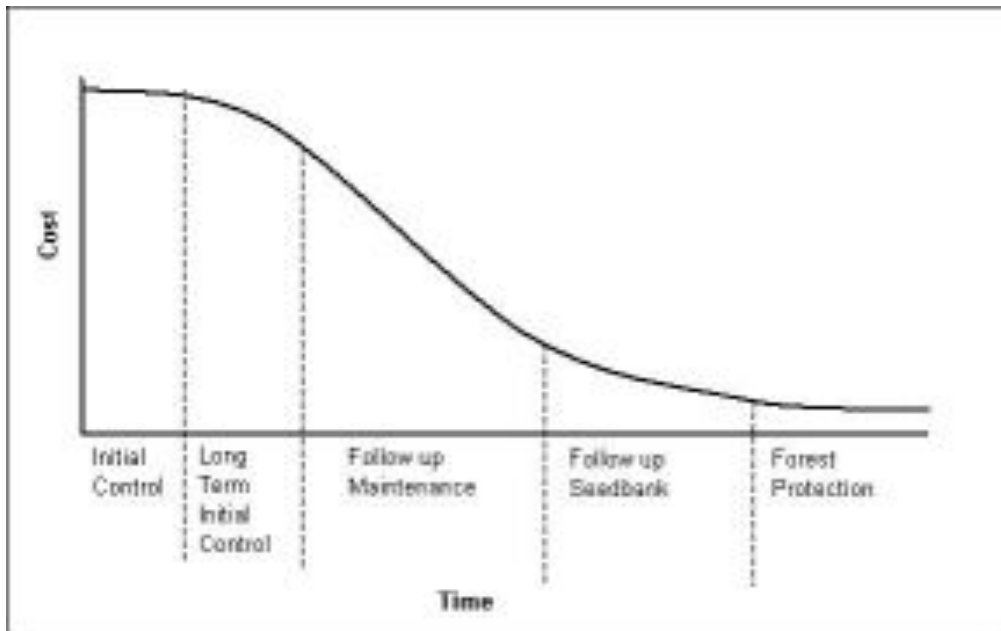
Figure 9. Theoretical representation of cost of weed control (i.e. amount of weed control required) over time, as a site moves through different weed control phases

If restoration efforts are coordinated to allow for long-term weed maintenance, the cost, labour and herbicide requirements for Oakley Creek will steadily decrease over time and should eventually be reduced to a minimum level as depicted in the graph below (Figure 9).

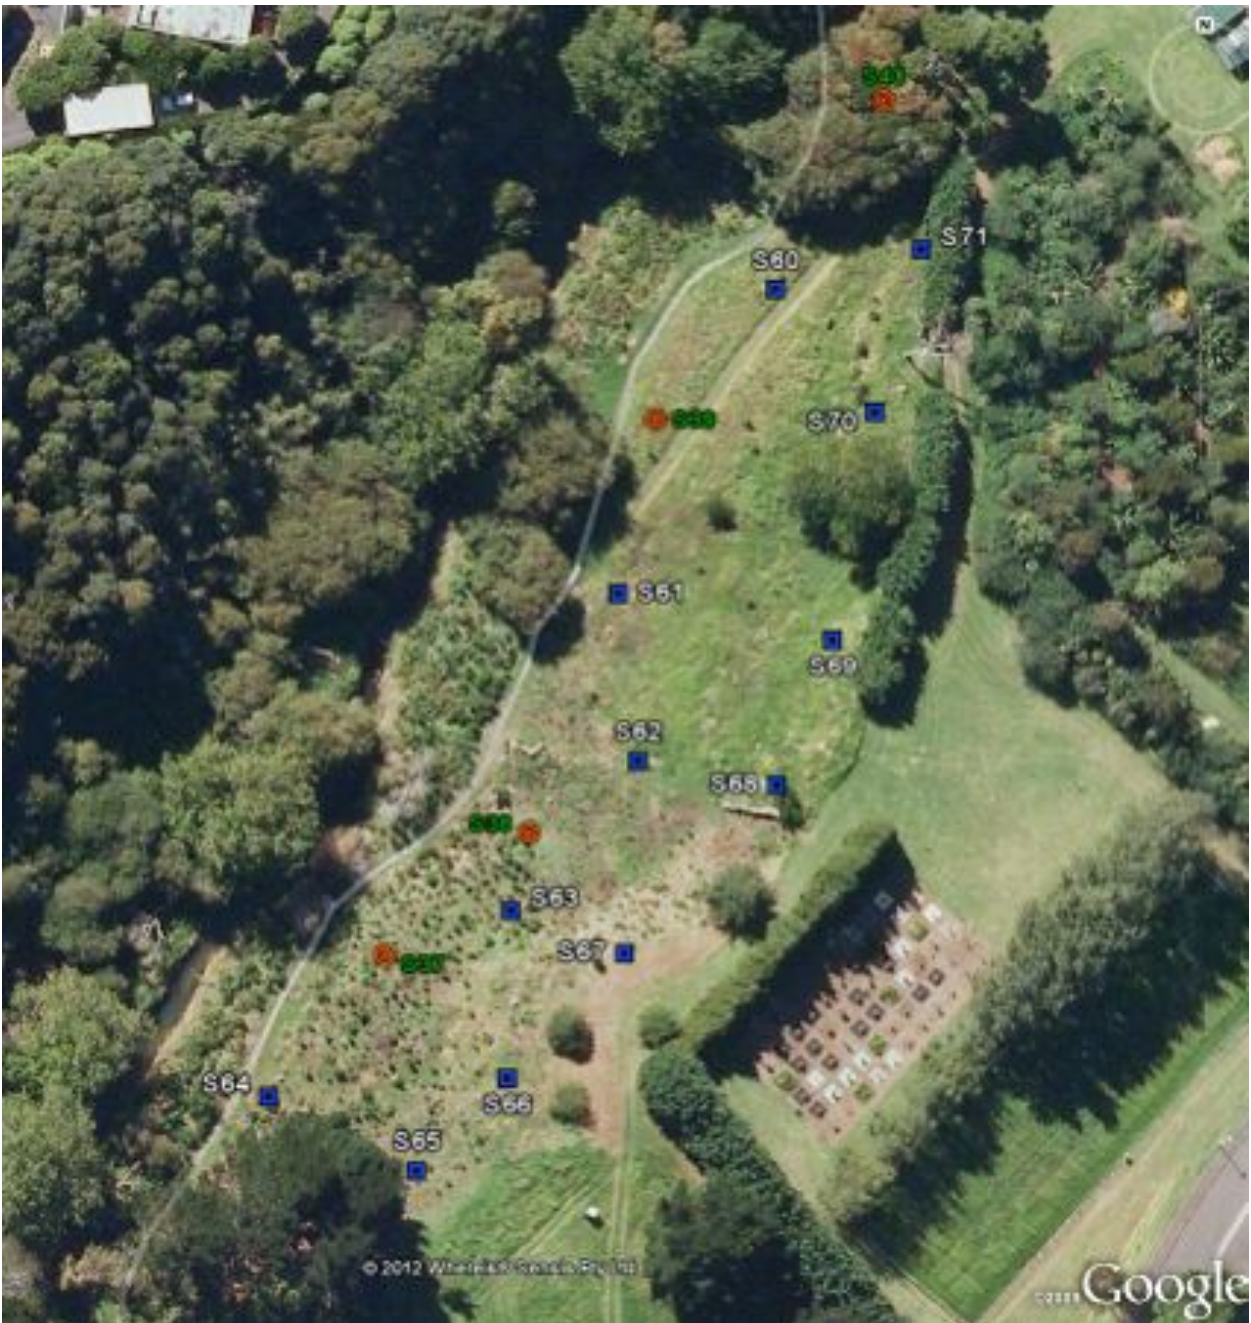
Figure 11. Location of additional rodent bait stations in Oakley Creek Lizard Management Area in MU 3a (map created in December 2012 by Te Ngahere)

Note: Orange / Green indicates existing rodent bait station set-up by Friends of Oakley Creek. Blue (S60 - S71) refers to additional bait stations installed for lizard enhancement works.

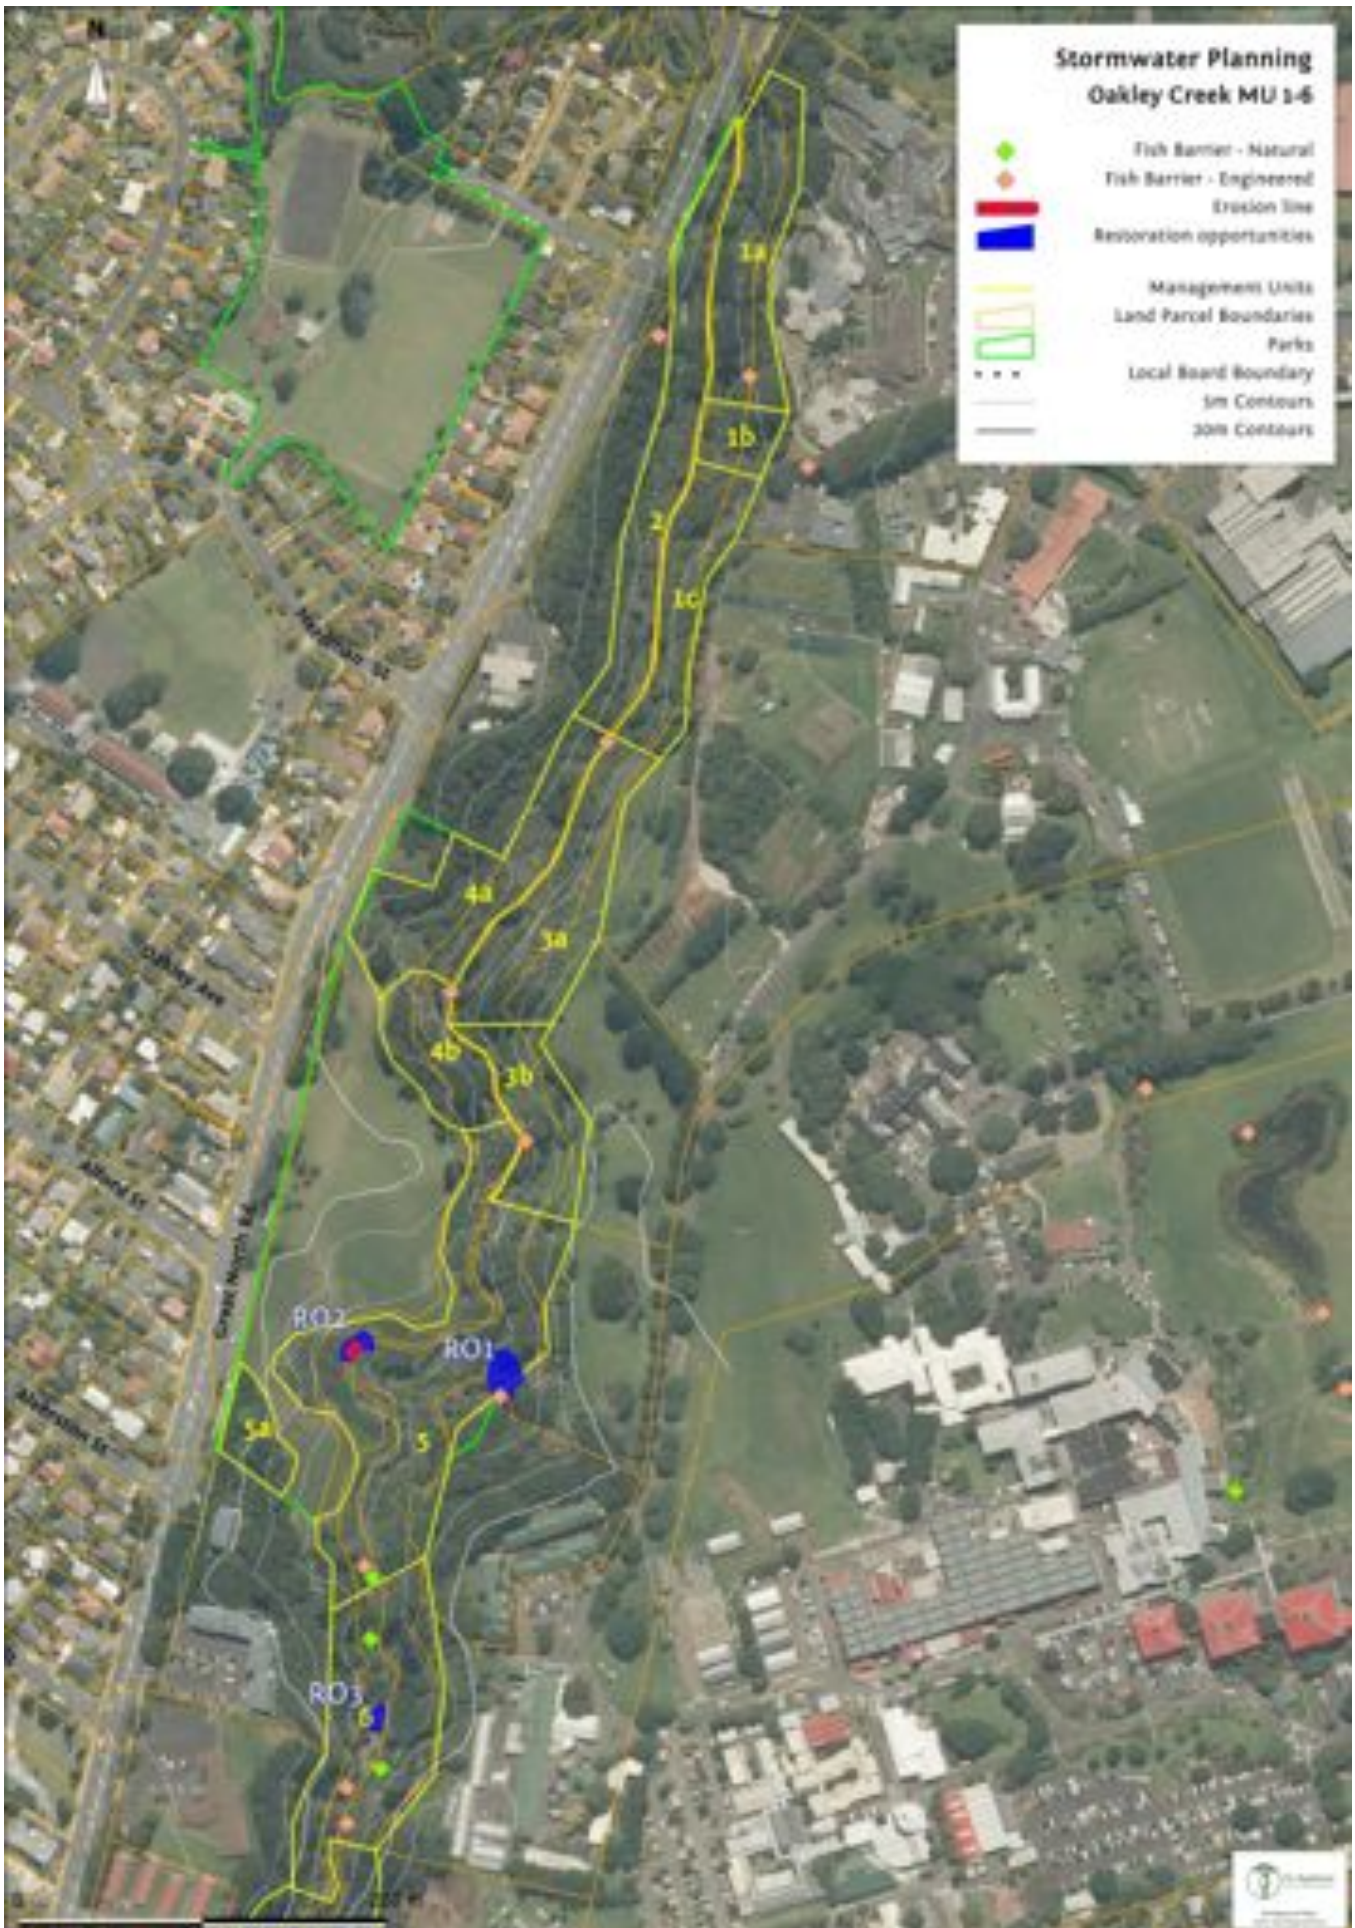
Figure 17. Stormwater Planning map MU 1-6

Refer to the Appendix (Figure 17 and Figure 18) for maps showing stormwater planning / mitigation sites along Oakley Creek (fish barriers, Restoration Opportunities and erosion areas).

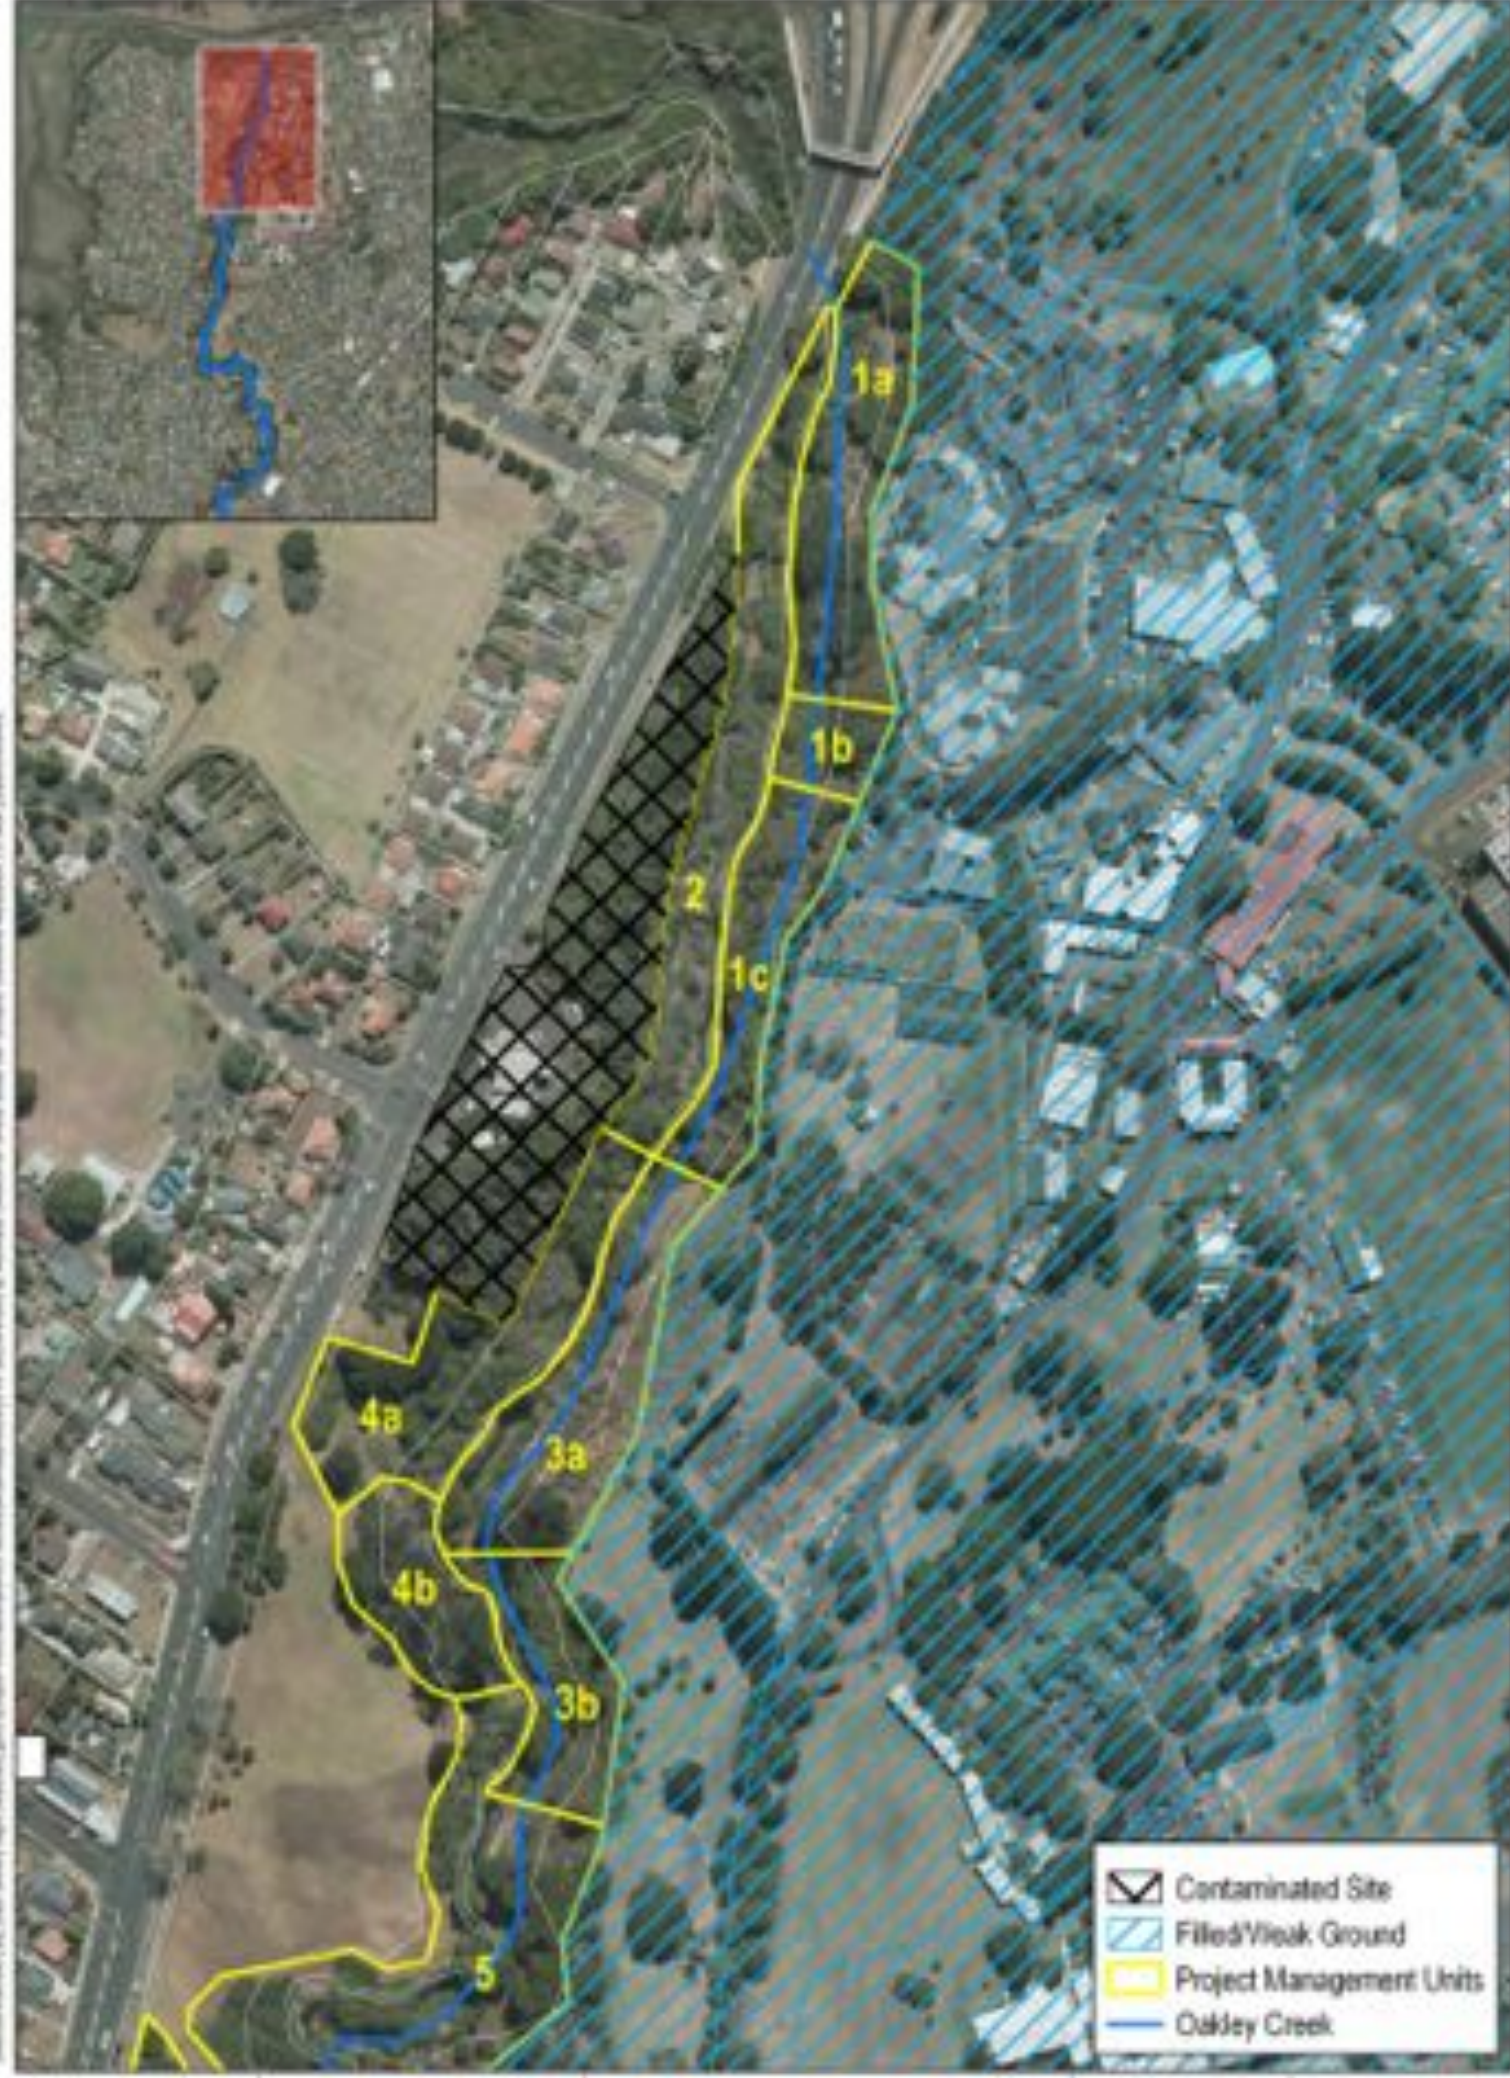
### Oakley Creek Ecological Restoration Project HAIL Maps

Source: AECOM, 2017. Oakley Creek is shown in blue. Contaminated sites are shown in black cross-hatch. Filled/leak ground is shown in blue diagonal lines. Project Management Units are shown in yellow. Oakley Creek is shown in blue.

-   Contaminated Site
-   Filled/Leak Ground
-   Project Management Units
-   Oakley Creek
