**AUCKLAND
WATERWAYS**

Our drainage network
resource consent project

Oakley Creek Watercourse Management Plan

October 2010

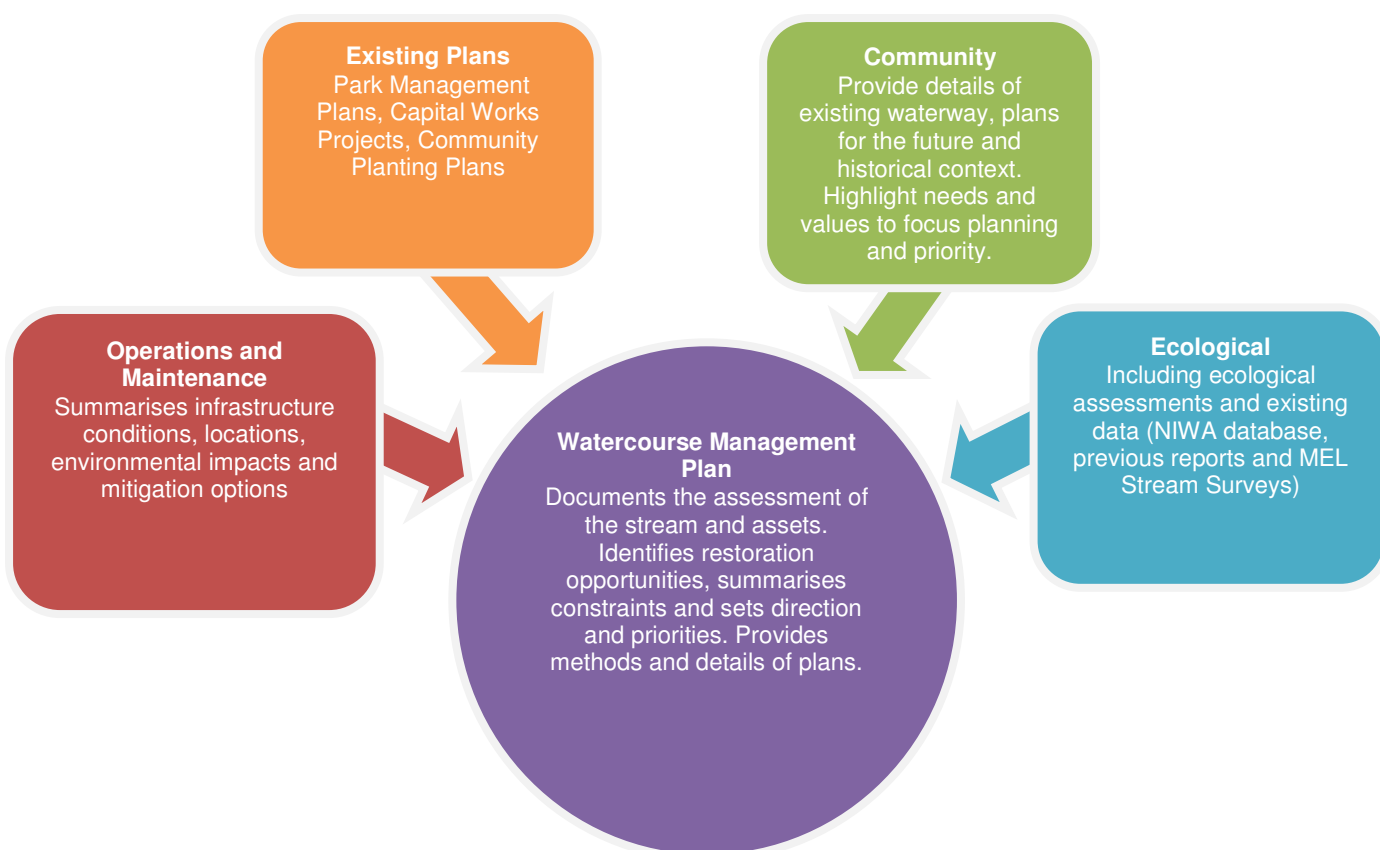
Figure 2: Watercourse Management Plan Input Diagram

These elements should serve to achieve the multiple objectives of the WMP. The diagram shown in Figure 2 illustrates the combination of elements required to develop the WMP.

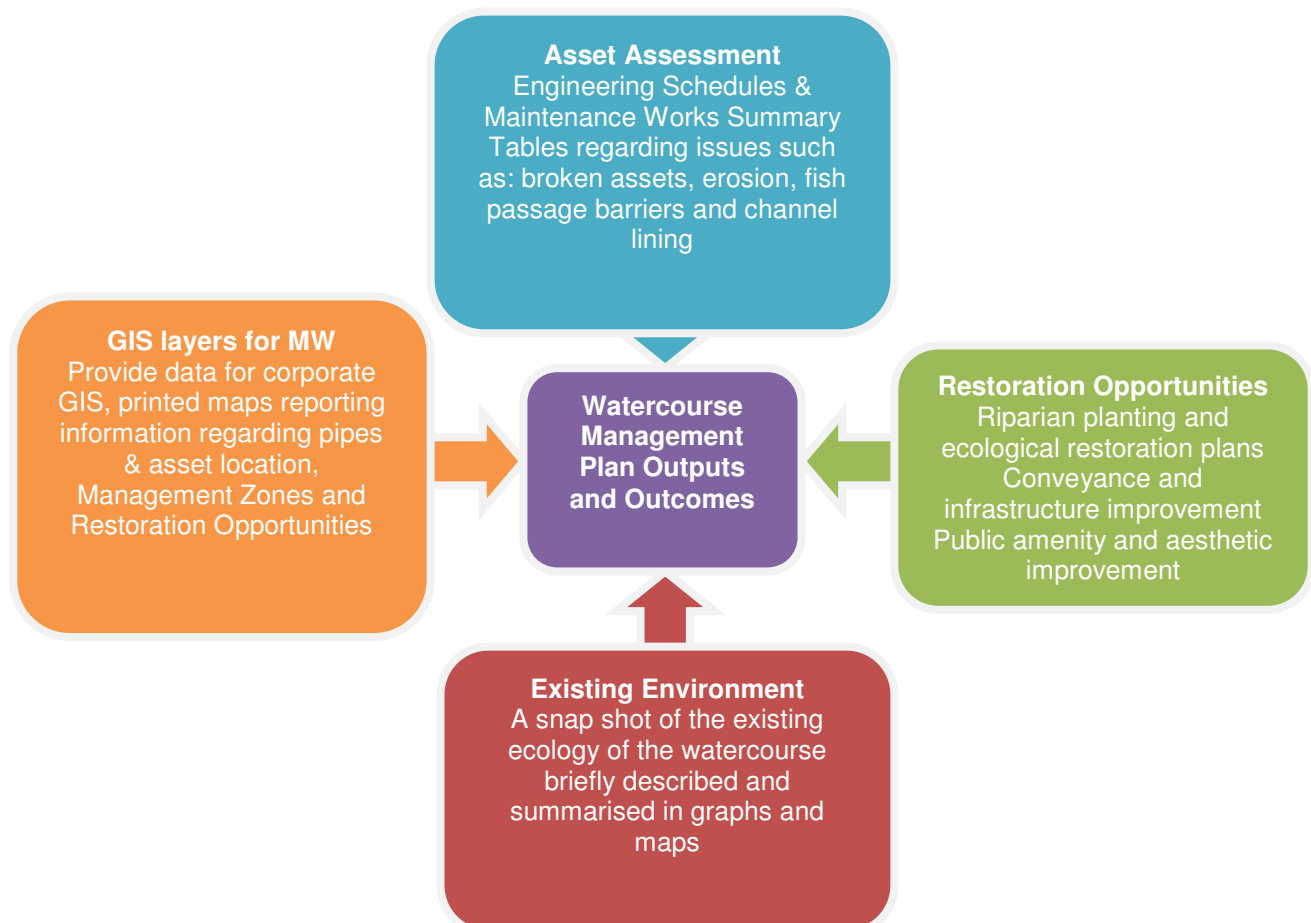
Figure 3: Outputs and Outcomes of the WMP

The WMP is a living document, with information sets that are viewable through GIS and supported through updated information when available. The information flows and outputs are shown in Figure 3 to illustrate these processes.

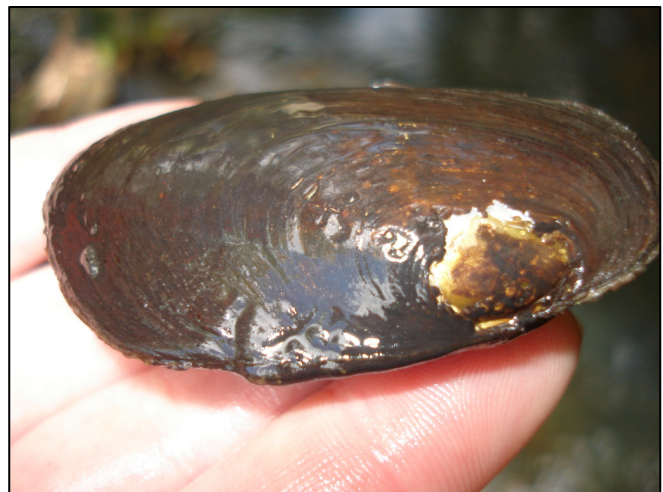
Figure 6: Freshwater mussel found in lower reaches of Oakley Creek during Stream Walk (10/03/09)

Oakley Creek is likely to retain a small population of the native freshwater mussel *Hyridella menziesi* in the lower reaches. Previous macroinvertebrate studies (e.g. Moore, 2009) have noted specimens near the litter trap in the very lower reaches of the creek. During the course of the stream walk another specimen was located further upstream, near the Unitec entrance to the creek walkway. Freshwater mussels are a 6 on the MCI-SB index and are indicative of moderate to good water quality (Stark & Maxted, 2004). This is a significant finding for the creek as it shows the water quality is sufficiently high to support good quality fauna.

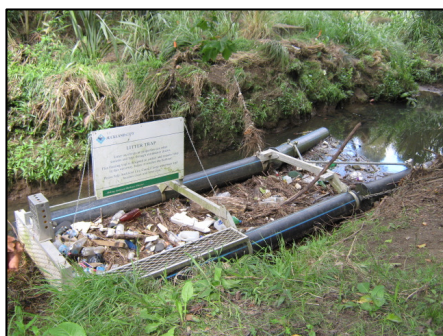
Figure 7: Floating Litter Trap (NT1416) in Oak_3, Oakley Creek

There is a floating litter trap (NT1416) located at 1404 Great North Road in reach Oak_3 in the Oakley Creek Esplanade Reserve (see Appendix A, Map 6a).

The litter trap may not be performing at its optimum performance due to excessive debris and litter. In addition it appears that the trap may be exacerbating localised erosion. This may be due to the inefficient nature of the litter trap blocking and diverting flows. It is recommended that routine cleaning and maintenance increases in frequency and measures are taken to decrease erosion.

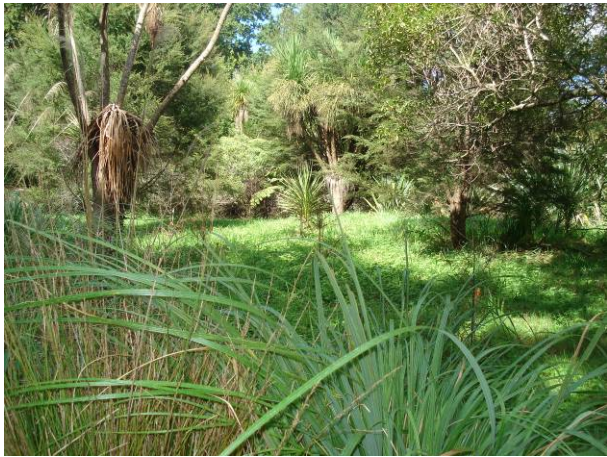
| Photo | | | | | | | |

| Comments | <p>Located at the head of a concrete lined channel, a suspected leaking stormwater manhole has created a wetted area. This is adjacent to existing (and ongoing) planting carried out by Friends of Oakley Creek. Some minor erosion scars are evident below the rock dam in the main channel, but there is no significant erosion in the surrounding area.</p> <p>Restoration objectives:</p> <ul style="list-style-type: none"> - Re-engineer a naturalised channel in line with conveyance objectives - Create wetland at head of engineered channel and plant appropriately <ul style="list-style-type: none"> o Investigate assets at head – potentially wet due to damaged assets | | | | | | |

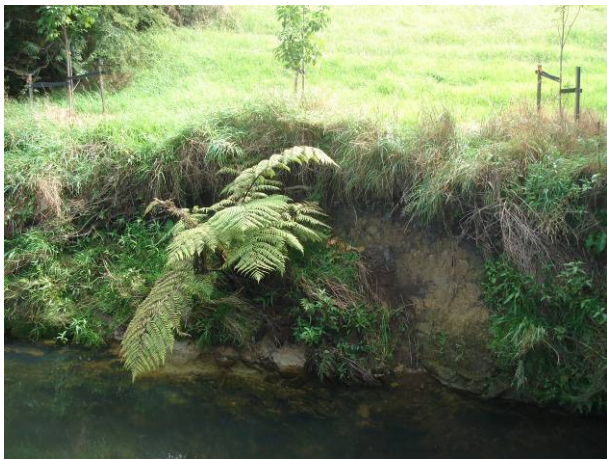
| Photo | <p style="text-align: center;">Figure 9: Oakley Creek RO-2. (Photocode: 8371)</p> | | | | | | | |

| Comments | <p>Waterview Glades is a reserve on the TLB of Oakley Creek, running alongside Great North Road. A relatively stable erosion hotspot has been identified on the TLB of the creek which requires maintenance.</p> <p>Additional to regular maintenance, it is recommended that the area is restored to improve amenity and bank stability/conveyance. There are four juvenile trees currently planted but more are required. There is a deep pool directly below the erosion and a pest fish (goldfish or koi carp) immediately upstream. The reserve maybe impacted during construction of the SH20 Motorway extension.</p> <p>Restoration objectives:</p> <ul style="list-style-type: none"> - Plant on TLB to a minimum of 10 m and reinforce as necessary to improve bank stability. This may require battering back the bank. - All restoration plans need to consider conveyance efficiency - Potential to improve amenity from the TLB by building a platform to look over the creek and into the planted area on the TRB | | | | | | | |

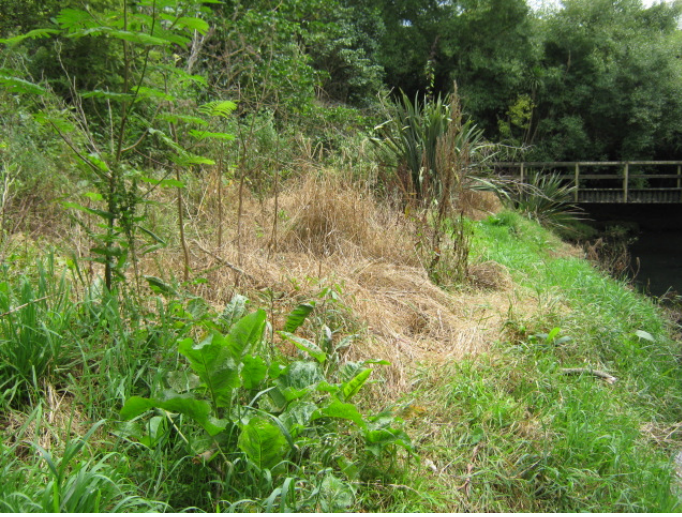
| | <p>Figure 13: Oakley Creek RO-5. (Photocode: 1632)</p> | | | | | | |

| Comments | <p>The footbridge linking Blockhouse Bay Road and Great North Road with the TRB side of Oakley Creek. Upstream of the bridge is an accessible area that is currently weedy and overgrown. Weed control and installation of a bench seat or other amenity facility would improve the amenity of the site and provide a relaxing streamside resting place. Improving shading along the length of the RO would improve native biodiversity on the banks and assist in maintaining bank stability. Close to the waters edge, low growing, floodplain plants are recommended to assist in filtering and slowing water in high flows.</p> <p>Restoration objectives:</p> <ul style="list-style-type: none"> - Improve shading and amenity by improving native vegetation density back from the walkway - Improve biodiversity by carrying out weed removal and ensuring ongoing management in line with the Friends of Oakley Creek weed management plan - Improve amenity by installing a bench seating - Consider safety by upgrading pathways and providing lighting | | | | | | |

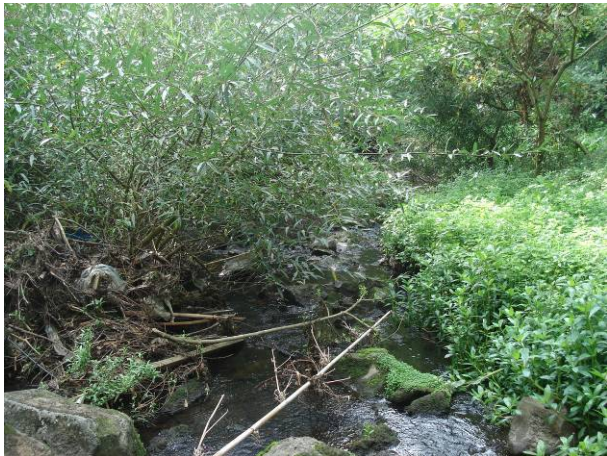
| Photo | <p>Figure 20: Oakley Creek RO-12. (Photocode: 8936)</p> | | | | | | | |

| Comments | <p>This section of stream consists of bedrock and boulder substrates forming a series of cascades and has no public access. Willows are currently growing in the centre of the stream and have the potential to cause conveyance issues and debris jams.</p> <p>Restoration objectives:</p> <ul style="list-style-type: none"> - Improve and maintain conveyance through the reach by selected willow removal - Weed management on both banks - Rubbish and debris clearance required and ongoing maintenance to ensure limited rubbish enters the stream - Despite high velocity turbulent flow over the cascades, a significant coverage of periphyton is present. Increase shading where possible to reduce occurrence of periphyton in-stream. | | | | | | | |

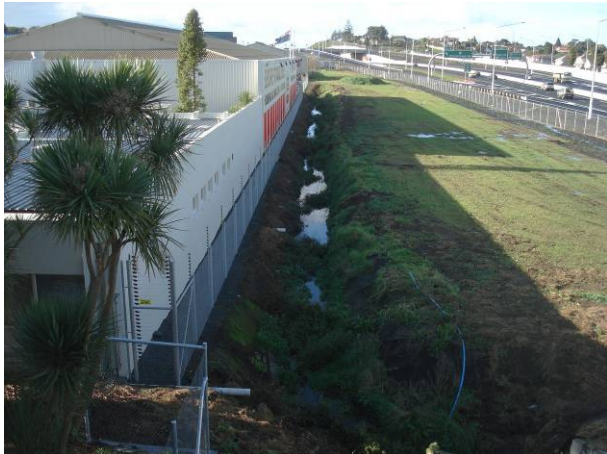
| | <p>Figure 25: Oakley Creek RO-17. (Photocode:447)</p> | | | | | | |

| Comments | <p>Behind the industrial area at Carr Road, Mt Roskill, a short section of Oakley Creek remains open following the SH20 motorway extension. The area is very boggy and consists of a single channel similar to a typical road drain. There are some existing plantings close to the motorway, consisting of low growing grasses. It is recommended that the site be planted extensively along the length to encourage lower in-stream temperatures and to improve amenity, particularly for users of the motorway. Planting will also reduce long-term maintenance costs as the plants mature. Existing overland flow paths may be a result of the motorway extension and could be contributing to the boggy nature of the site. Existing weedy vegetation and debris in stream is causing debris jams which may be reducing conveyance efficiency of the reach.</p> <p>Restoration objectives:</p> <ul style="list-style-type: none"> - Carry out extensive revegetation of the site including planting to the motorway edge for biodiversity, amenity and in-stream ecological functions - Remove in-stream debris jams to improve conveyance - Establish a maintenance access point as part of any proposed restoration works | | | | | | |
