Appendix D: Extract from Druskovich (2009) – Section 4**4. ARCHAEOLOGICAL SITE AND MANAGEMENT UNIT RECOMMENDATIONS**

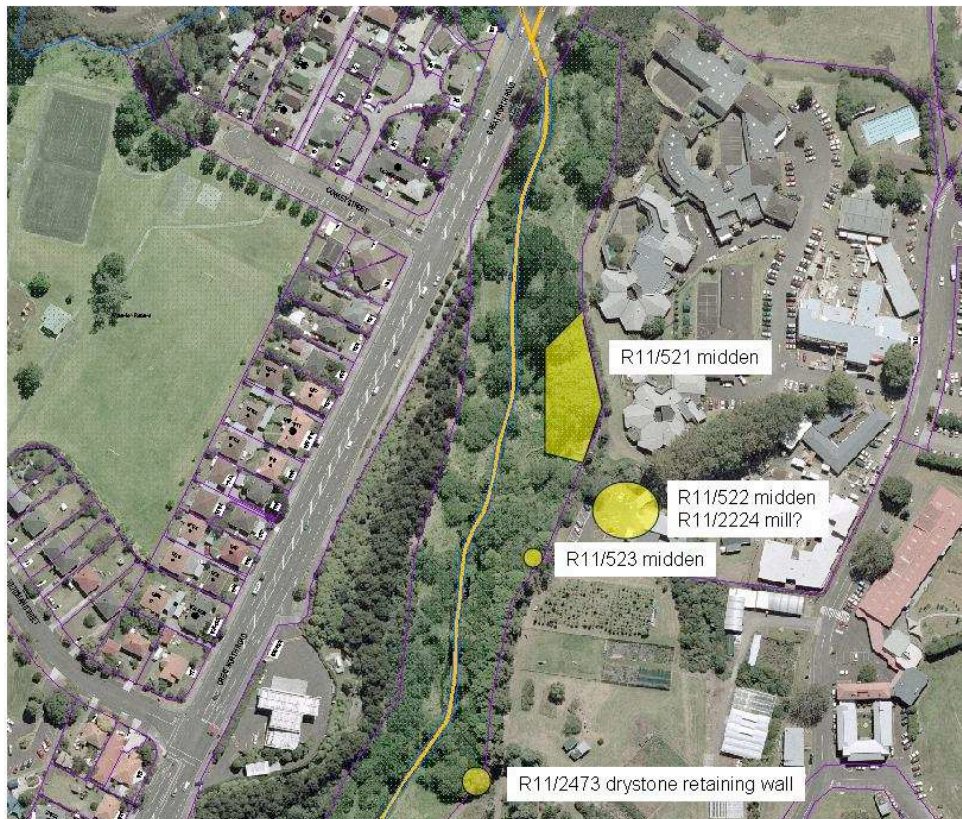
Figure 3 Recorded archaeological sites at the northern end of the Oakley Creek Revegetation Programme Area.

Midden from site R11/521 is readily visible spilling onto the path and on some of the slopes within this area, shell is found subsurface on the relatively flat banks above the slopes and is spread over a considerable area in the southern half of this management unit up to the Mason Clinic fenceline (refer Figure 3 – note limits shown on figure are approximate). It is also likely to be found within the clinic grounds as well, however this is not shown on the figure as the limits are unknown.

Some recent plantings have occurred over this midden, including Puriri, which have large root systems and are likely to cause long term damage to this site. The following recommendations do not apply to the mature trees already present.

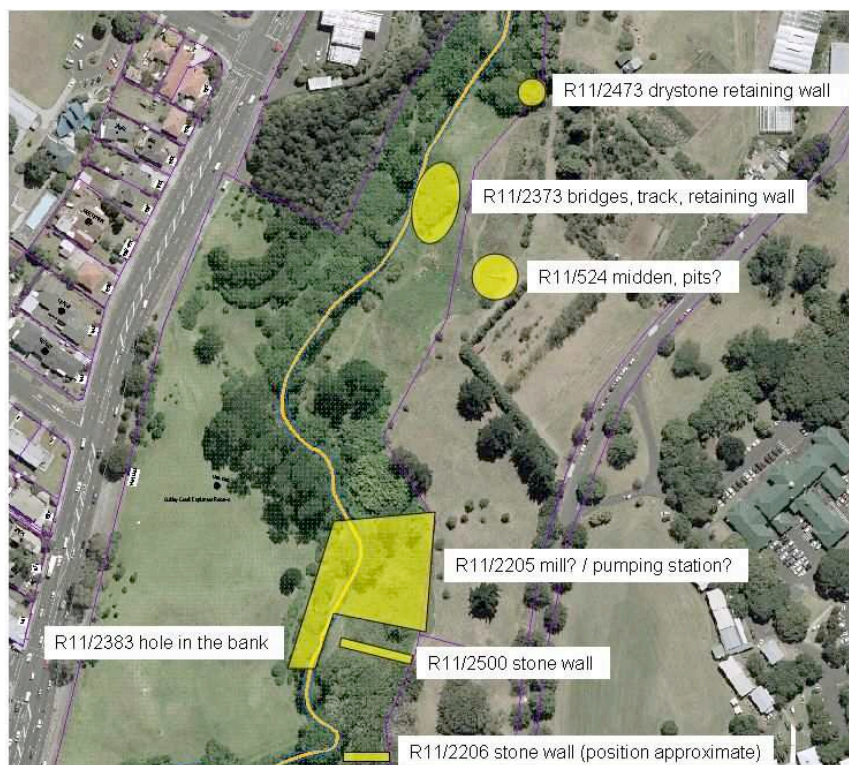
Figure 4. Archaeological site locations, Oakley Creek, Waterview.

This site (refer Figure 4 – the area marked is an indication only, the limits shown should be viewed as a minimum extent of the site) is outside the management area, however related community planting has occurred on it and maybe ongoing. All community plantings should cease in this area. An Authority to modify an archaeological site should be sought if planting is to continue. Some of the plantings, if they are of trees with large root systems should be reviewed. I note that as it lies outside the area addressed by Habgood (2005) it maybe necessary to establish who has ownership of the land here and what body should take responsibility for its implementation.

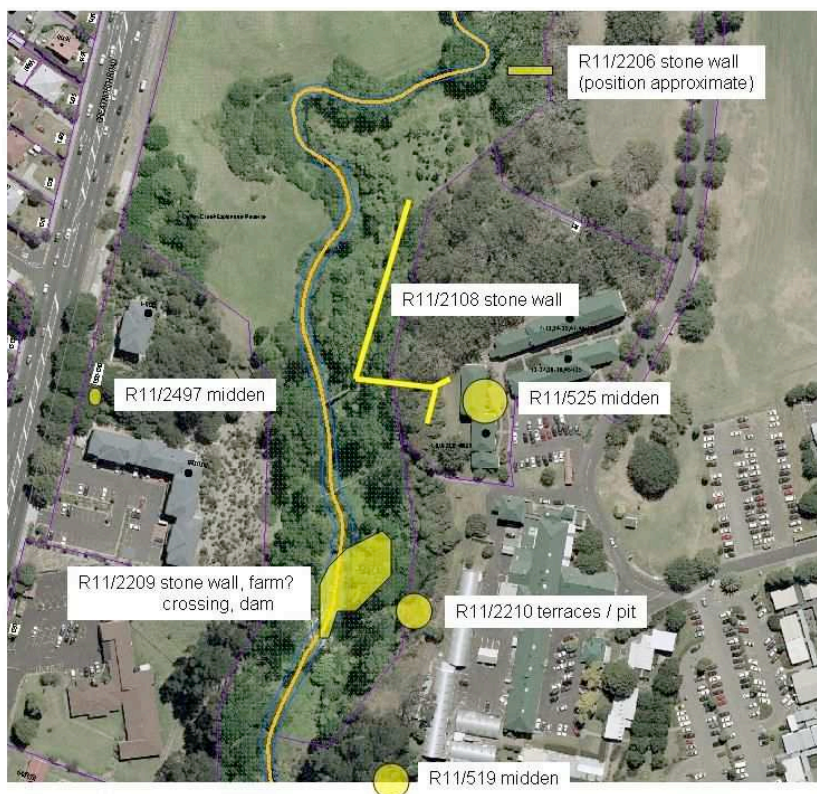
Figure 5. Archaeological site locations, in the vicinity of the waterfall and walkway access between Unitec and Great South Road.

The pit is well defined, however the terraces are more difficult to define as vegetation, including fallen trees obscure the ground surface in this vicinity. Whereas the terrace that the pit is located upon is almost definitely real, it cannot be certain that the other is. It may be a result of slumping, part of an old track (as it appears to slope towards the old tracks south of the waterfall or possibly caused by past tree falls). Planting has occurred in this vicinity, though none are close to the pit. The area marked on Figure 5 should be looked upon as indicative only, it maybe slightly further west than shown.

- jj) No plantings of vegetation should occur on, in or around the pit and selective maintenance of self sown species should be maintained so that unsuitable species do not grown within or adjacent to the pit.
- kk) If in the future the area is cleared of vegetation an archaeologist should be given the opportunity to better investigate and define the site and questionable terraces.

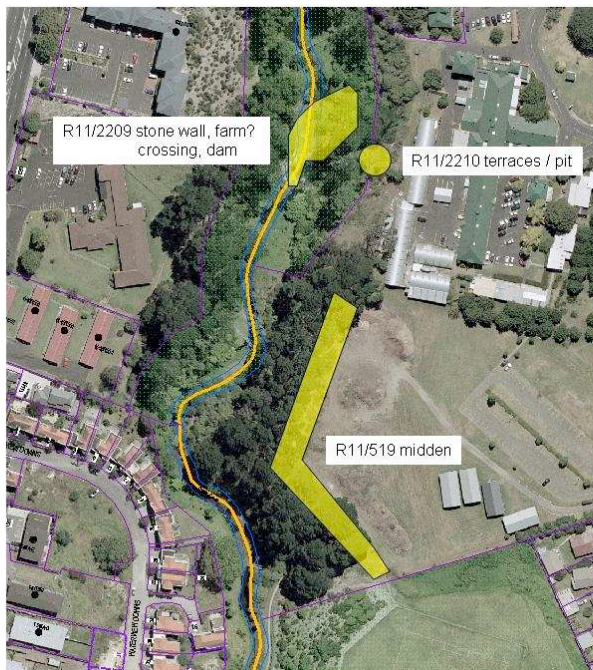
Figure 6. Archaeological site locations adjacent to Management Unit 7.

The long midden site R11/519 is located beneath and adjacent to the pines on the Unitec grounds to the east of MU 7 (Figure 6.) Probing and visual survey indicates that this midden is confined to the top of the bank and the first 3m below it (occasional slopewash individual shells excepted). No archaeological evidence was found within the Management Unit. It is understood however that outside the boundaries of the MU, volunteers are planting higher on the banks and should they continue planting towards the top of the bank they may encounter archaeological evidence.

- mm) Unless a distinct deposit of midden including shell and ash, as opposed to a few displaced shells, is found during revegetation or other works it can be ignored as it is likely to have been displaced by past works. If a distinct deposit is found in Management Unit 7 an archaeologist should be called on site to assess whether it is likely to be in-situ or not.

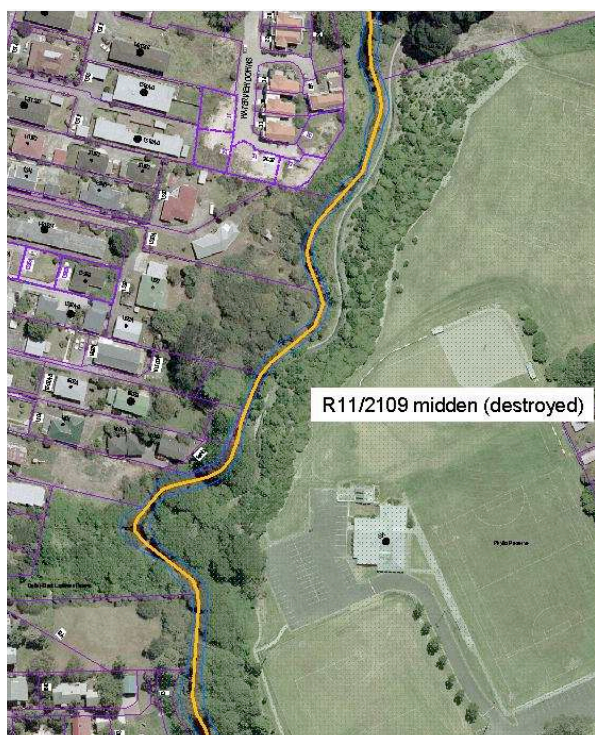
Figure 7. Locations of destroyed site R11/2109 adjacent to Management Unit 7.

Further along the walkway, beneath the Albie Turner Fields (refer figure 7), R11/2109 has been recorded. This site may have been a continuation of R11/519, however it has been destroyed by past quarrying, landfill and other earthworks activities. It is extremely unlikely that any intact deposits relating to this site have survived. It should not be viewed as an archaeological constraint.

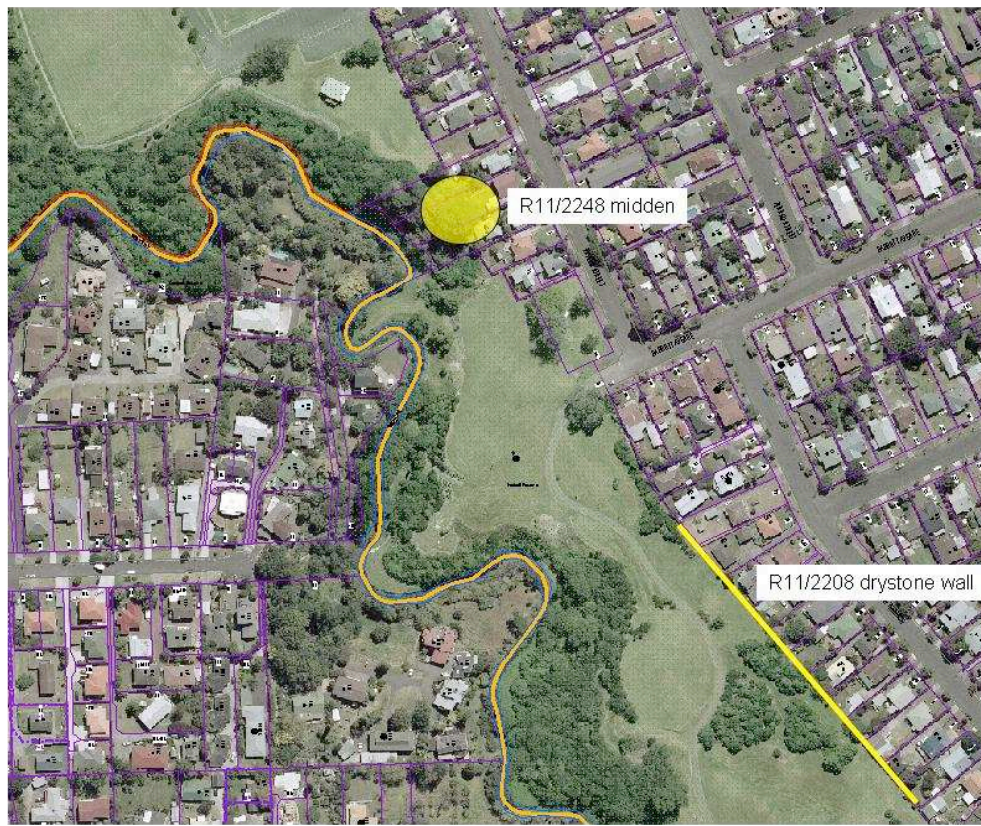
Figure 8. Archaeological sites recorded in the vicinity of Management Units 8 and 9.

No archaeological sites have been recorded within these management units, however evidence of both Maori occupation (R11/2109 and R11/2248) and historic farming practices (R11/2208) have been recorded nearby (Figures 7 and 8). No archaeological evidence has been found on or immediately adjacent to the walkways and grassed areas, or Oakley Creek itself. All of the vegetated banks in these management units are steep, and in places impossible to adequately survey. It would appear unlikely, but possible that archaeological evidence maybe found on these slopes, the most likely being midden deposits thrown down the slopes. It is therefore recommended that;

nn)If in the future the banks are cleared of vegetation an archaeologist should be given the opportunity to resurvey these areas.
